# Report to the Texas Coastal Coordination Council: CMP Cycle 14 Final Report: Mapping and Coring of the Inner shelf of Galveston Island-post Hurricane Ike

Dr. Timothy M. Dellapenna  
Kyle Johnson

Department of Marine Sciences, Texas A&M University at  
Galveston

A REPORT OF THE COASTAL COORDINATION COUNCIL PURSUANT TO  
THE NATIONAL OCEANIC AND ATMOSPHERIC ADMINISTRATION  
AWARD No. NA09NOS4190165

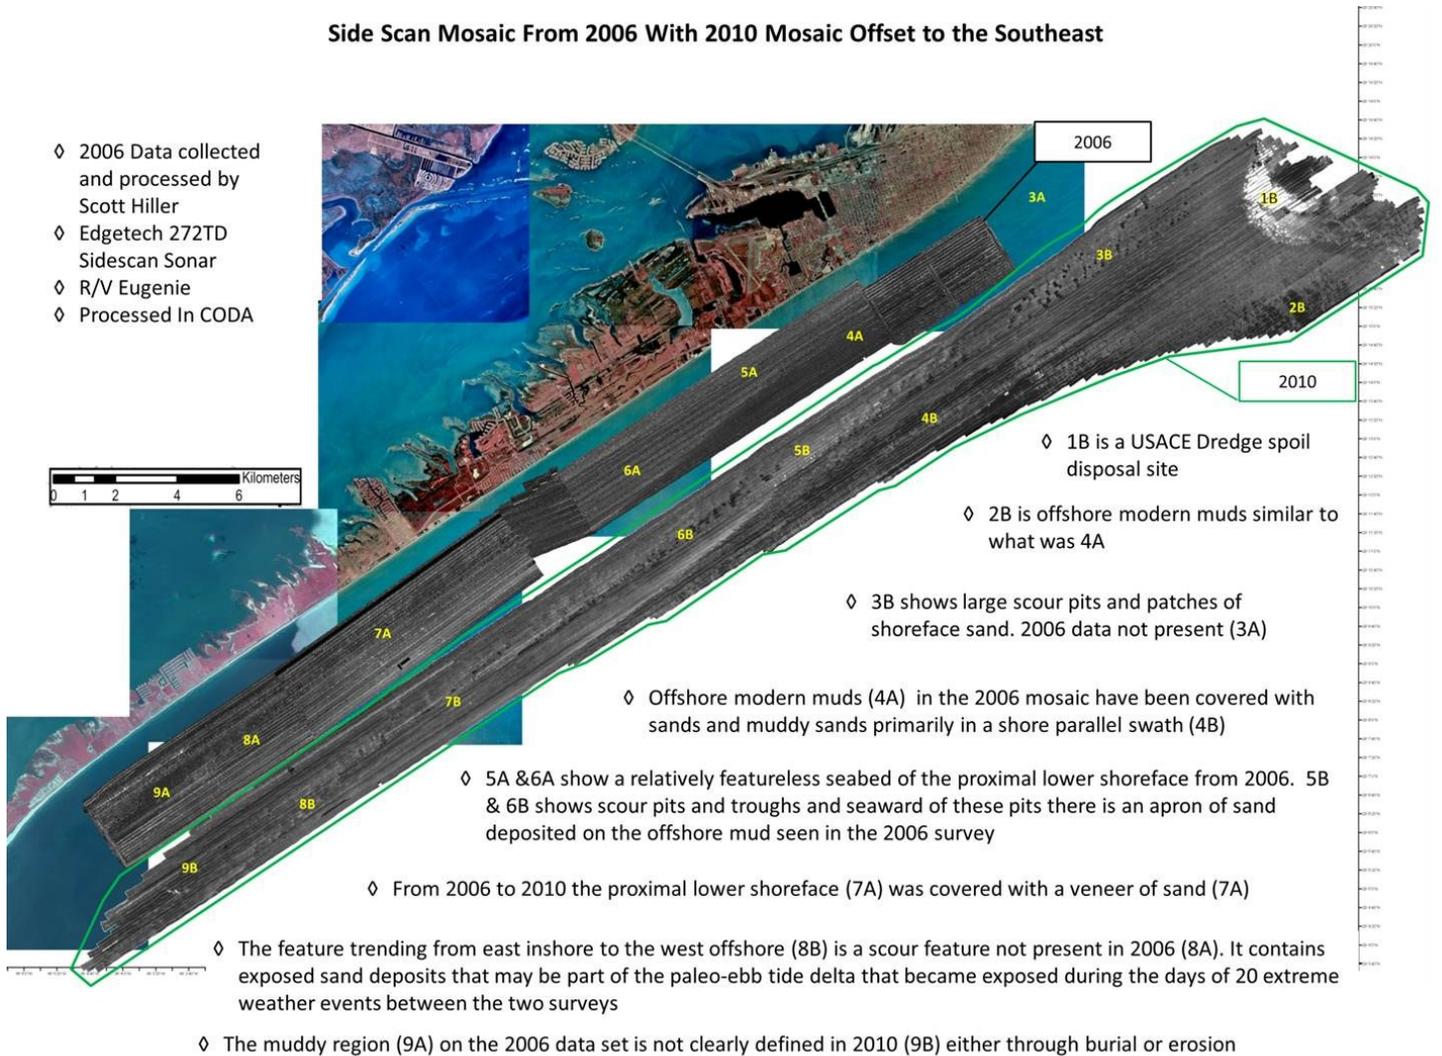
**FIGURE 3: Offset comparison of the CMP Cycle 10 survey in true location and CMP Cycle 14 survey offset to the Southeast by 4km. Annotations mark the same location between the two surveys**

There is a long bright feature extending from the 3m isobath offshore from 61<sup>st</sup> street offshore in a southwesterly direction to beyond the survey depth at the “G” core transect (Offshore of Terramar). This feature is a sandbar identified in Figure 20 as numbers 1, 5, and 6 which contains a large amount of sand in the surface sediments and is not present in the CMP Cycle 10 survey (Figures 3 & 16).

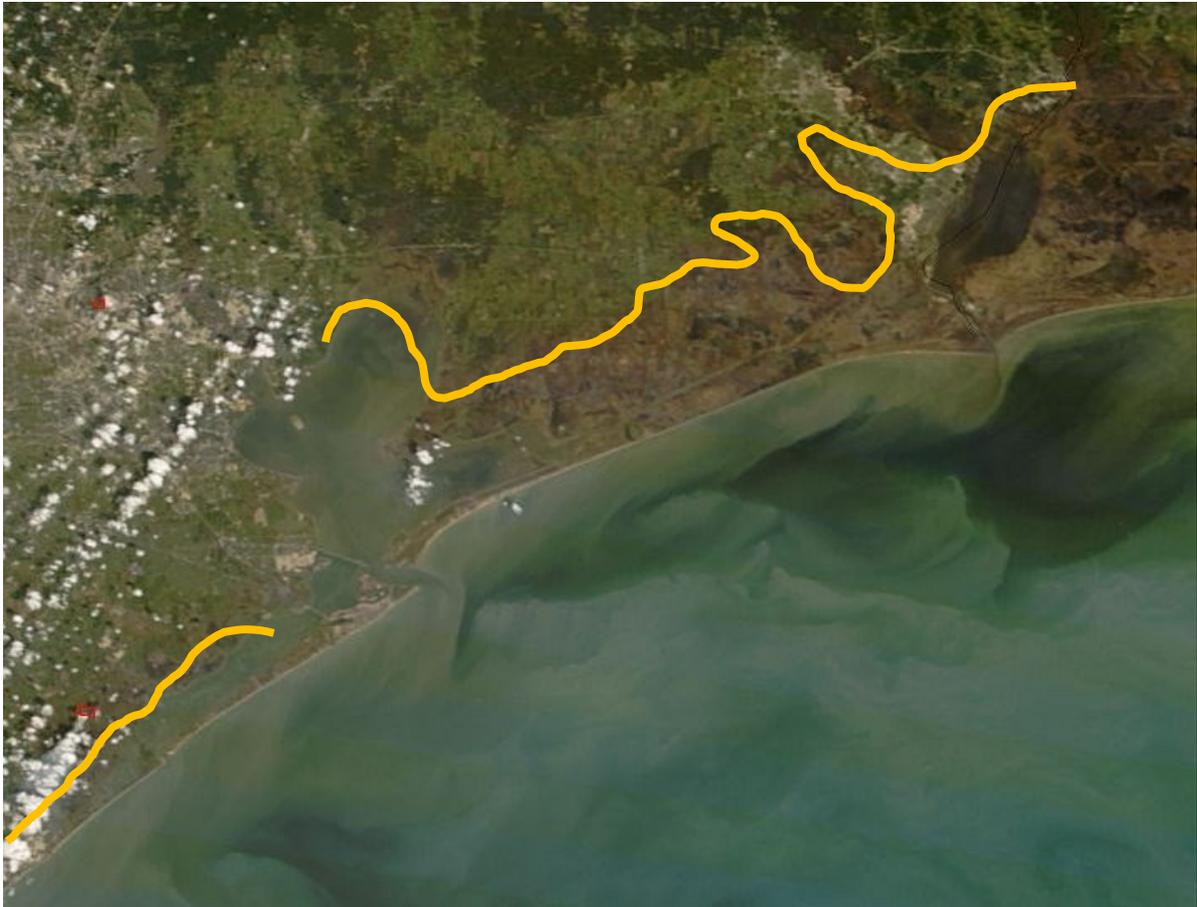
Figure 6. The yellow line delineates the approximate landward extent of dead vegetation as a result of Ike surge inundation (Courtesy of the U.S. Army Corps of Engineers)

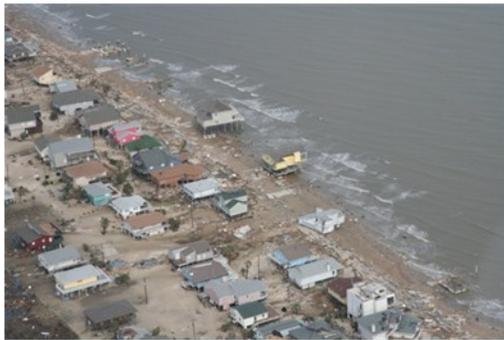
FIGURE 7

**Location 1:** Oblique aerial photography of Galveston, TX, on September 9, 2008 (top) and September 15, 2008, two days after landfall of Hurricane Ike (bottom). Yellow arrows mark features that appear in each image. Evidence of inundation here includes eroded beach face, sand deposited inland of the shoreline, and distressed vegetation. However, the coastal-change impacts were less severe here than on the Bolivar Peninsula, located northeast of landfall. [\[larger version\]](#)

FIGURES 7-10 are from the USGS showing the impact of select sections of the beach with oblique aerial photographs from pre- and post-Ike, showing the impact at each site. Included is also an inset map showing the location of each photoset. During the week prior to Hurricane Ike making landfall, Robert Webster, with the TAMUG Coastal Geology Laboratory conducted a series of beach profiles from the back of the dune to wading depth to establish base-line pre-storm conditions. Within a week of the storm making landfall, he repeated these profiles. FIGURE 11 contains a summary of his results (unpublished), showing both horizontal distance the tow of the beach moved (landward) and the vertical change (loss of elevation) of the beach across the transect. As FIGURE 11 shows, in general, both the vertical and horizontal changes decrease to the west

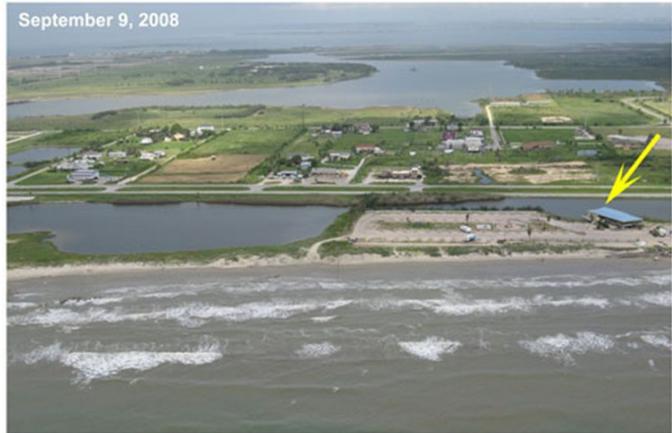
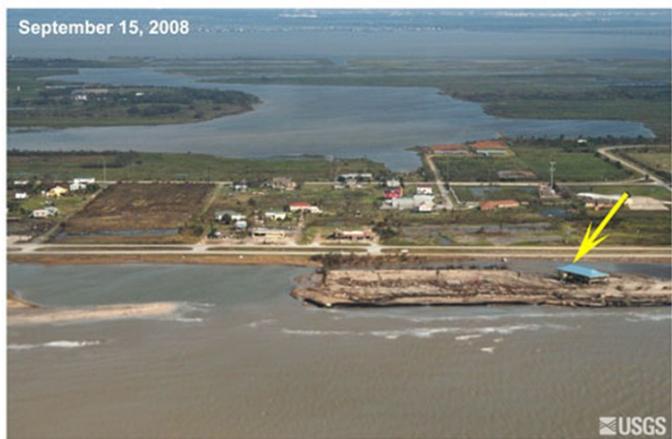
FIGURE 8

**Location 2:** Oblique aerial photography of Galveston, TX, on September 9, 2008 (top) and September 15, 2008, two days after landfall of Hurricane Ike (bottom). Yellow arrows mark features that appear in each image. Hurricane impacts include the breaching of a narrow spit and erosion of the Gulf-front beach.

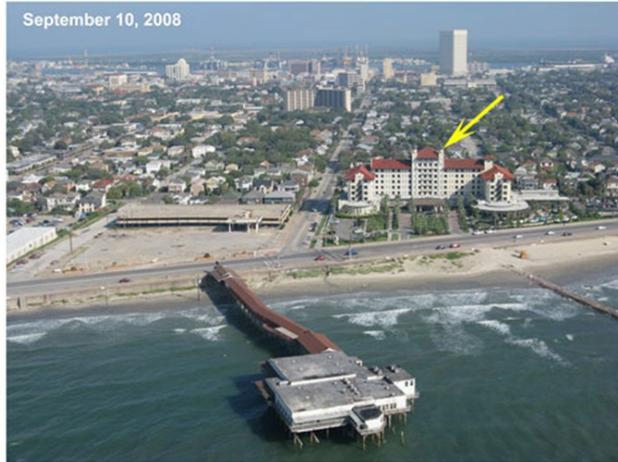
FIGURE 9

**Location 5:** Oblique aerial photography of Galveston, TX, on September 9, 2008 (top) and September 15, 2008, two days after landfall of Hurricane Ike (bottom). Yellow arrows mark features that appear in each image. Hurricane-induced waves and surge destroyed the historic Balinese Room and pier, and eroded adjacent beaches.

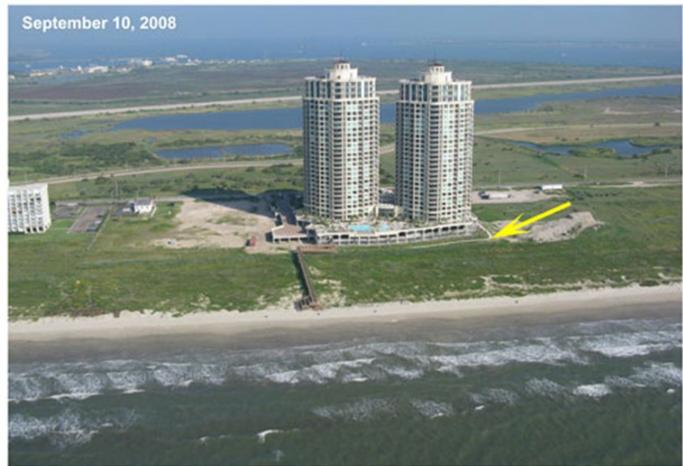
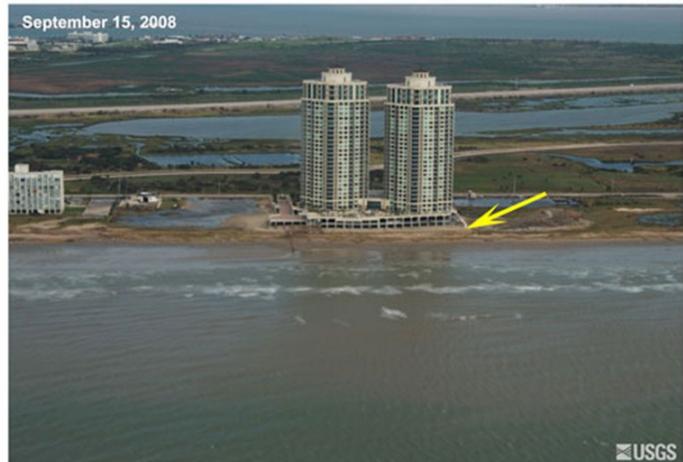
FIGURE 10

**Location 6:** Oblique aerial photography of Galveston, TX, on September 9, 2008 (top) and September 15, 2008, two days after landfall of Hurricane Ike (bottom). Yellow arrows mark features that appear in each image. Hurricane-induced waves and surge destroyed a small walkway. Coastal-change impacts include beach and dune erosion, and the removal of considerable dune vegetation. This location is on the right-hand side of the hurricane track and likely experienced the strongest winds, highest surge, and waves.
