ENDANGERED SEA TURTLE NESTING ACTIVITY ON UPPER TEXAS COAST BEACHES

Final Report to the

**In Fulfillment of
Contract #09-031-000-3348**

André M. Landry, Jr.

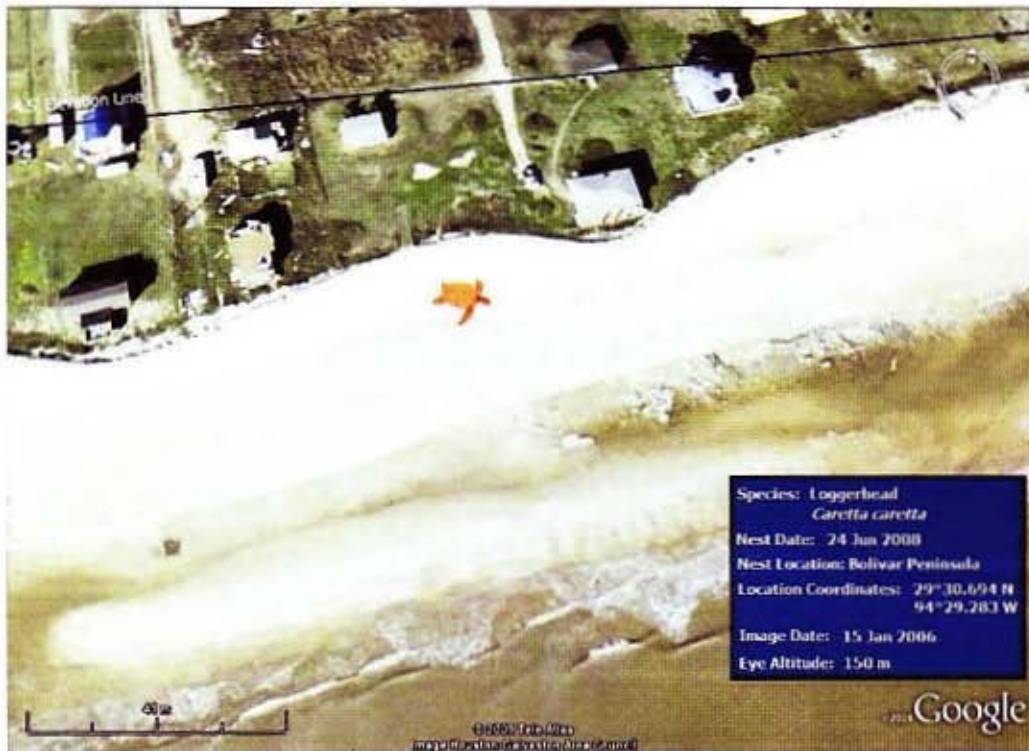
Figure 1. Pre-Hurricane Ike satellite photograph of a loggerhead sea turtle nest site laid on Bolivar Peninsula 24 June 2008. Turtle icon marks nest site.

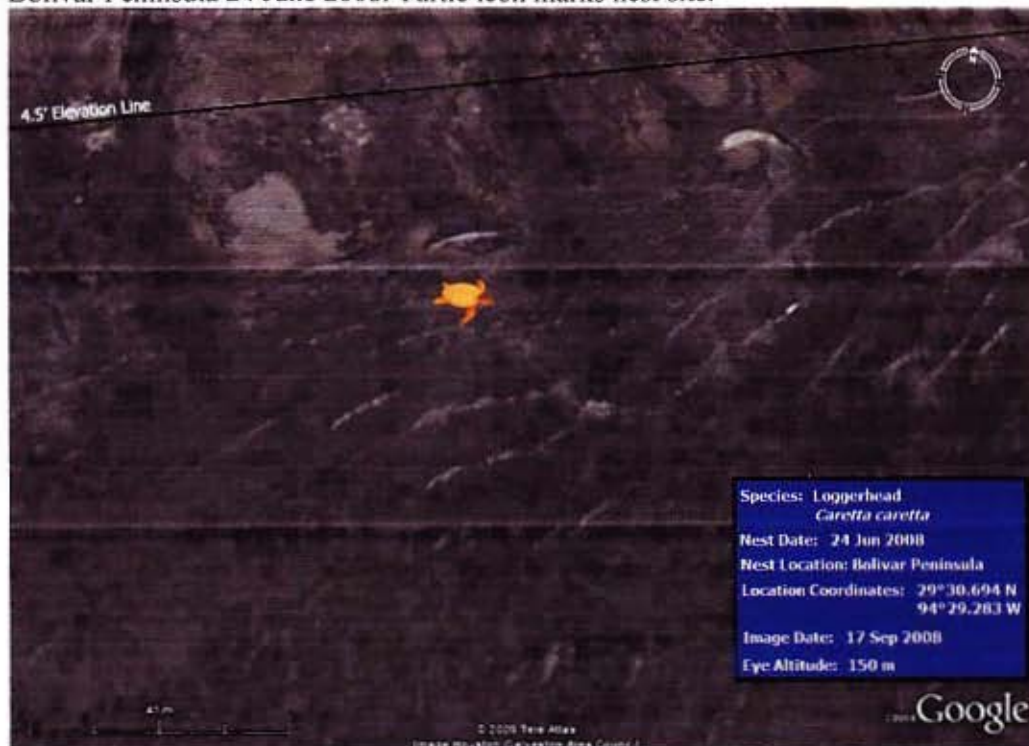
Figure 2. Post-Hurricane Ike satellite photograph of a loggerhead sea turtle nest site laid on Bolivar Peninsula 24 June 2008. Turtle icon marks original nest site. Dark coloration of photograph is due to terrain being under water.

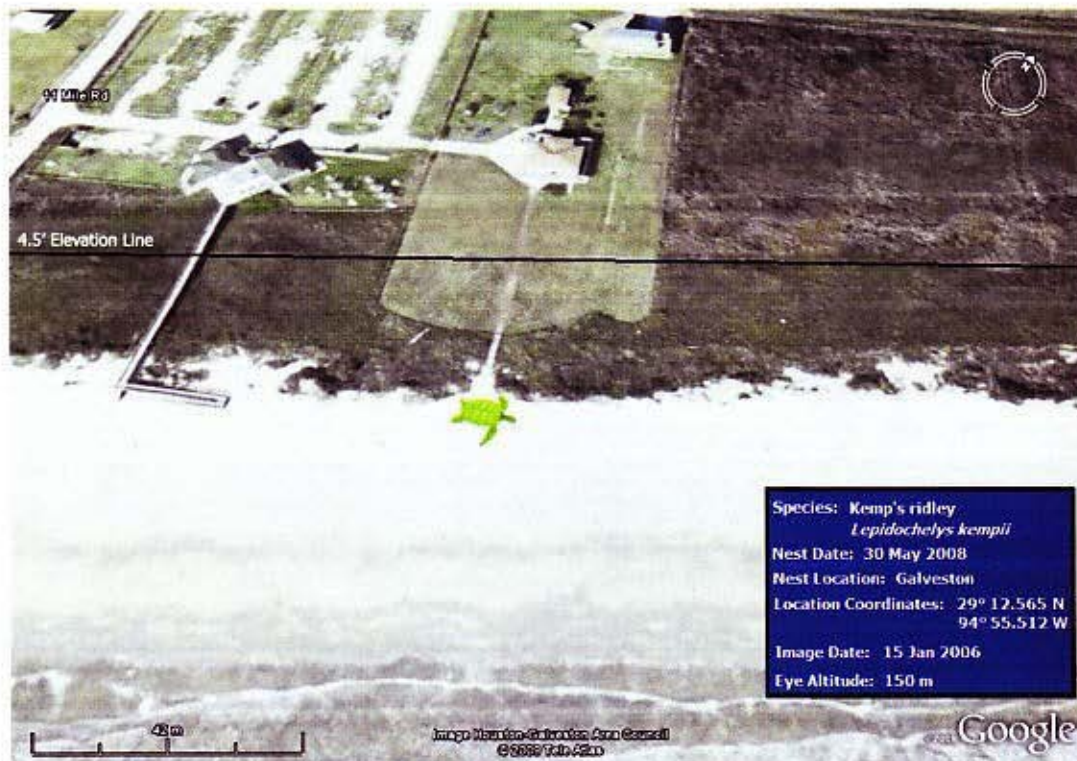
Figure 3. Pre-Hurricane Ike satellite photograph of a Kemp's ridley sea turtle nest site laid on West Galveston Island 30 May 2008. Turtle icon marks nest site.

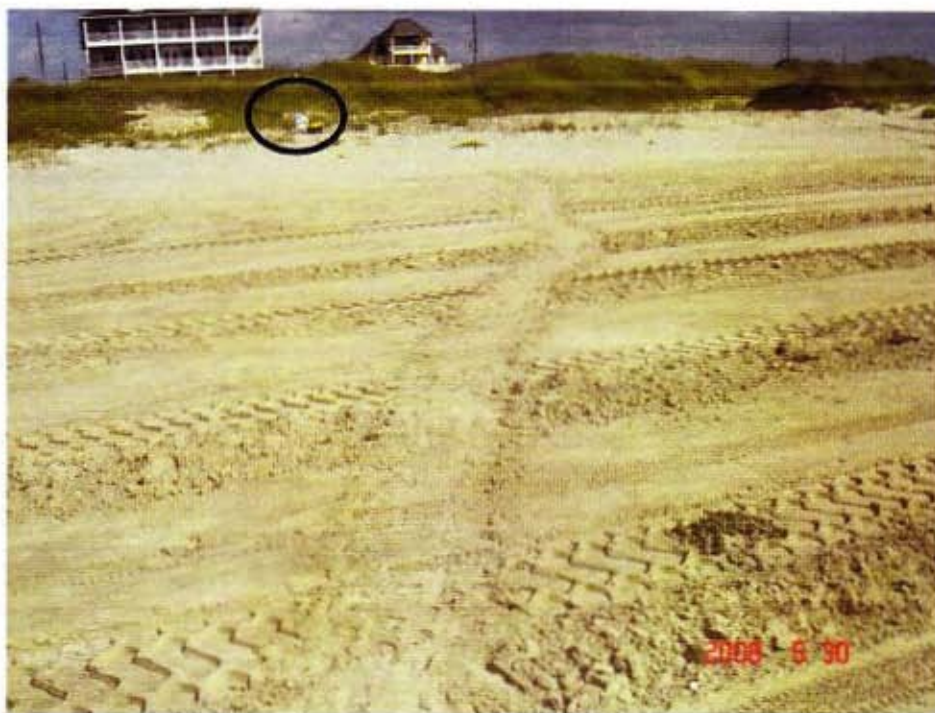
Figure 5. Pre-Hurricane Ike photograph of a Kemp's ridley nest site laid on Bolivar Peninsula May 30, 2008. Nest site is within dark oval.

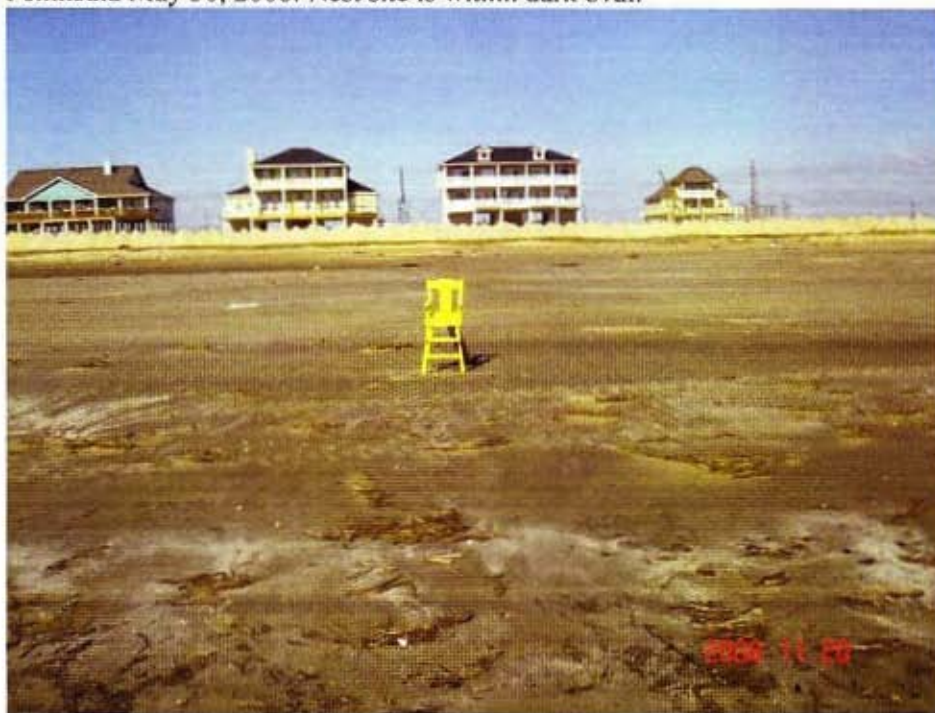
Figure 6. Post-Hurricane Ike (November 11, 2008) photograph of a Kemp's ridley nest site originally laid on Bolivar Peninsula May 30, 2008. Yellow chair marks original nest site.

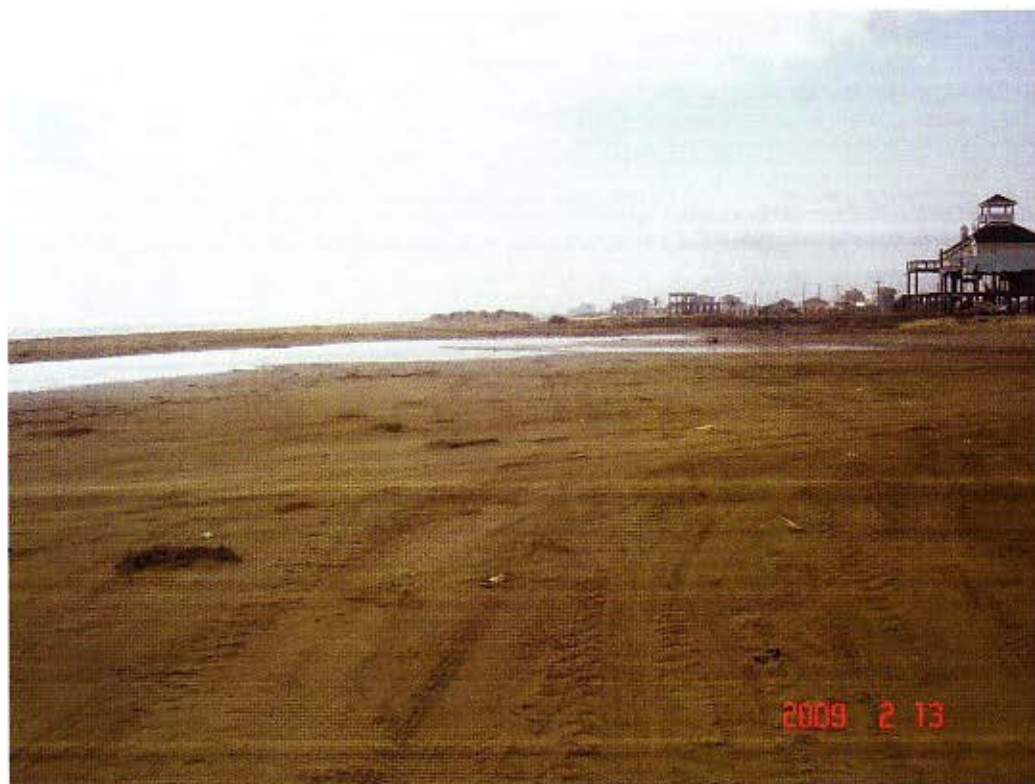
Inundated Beach Habitat: Standing water was a common sight on UTC beaches after Hurricane Ike and a condition that remains from High Island to Follett's Island (Fig. 7). This condition typically exists in areas where dunes were located pre-Ike and has been compounded by beach compaction due to heavy equipment used in moving sand back on the beach and later redistributing it. Tracks of nesters attempting to nest on beaches where standing water existed were often very circuitous and longer than those left by counterparts who nested on these beaches during pre-Ike seasons (Fig. 20). This pattern suggests nesters, upon encountering standing water on the beach, undertook extra effort to avoid it and continued to search for a suitable nest site nearby or simply turned gulfward in an aborted nesting attempt.

Figure 7. Storm-scoured, low lying area with standing water on Bolivar Peninsula where Kemp's ridleys had nested prior to Hurricane Ike.

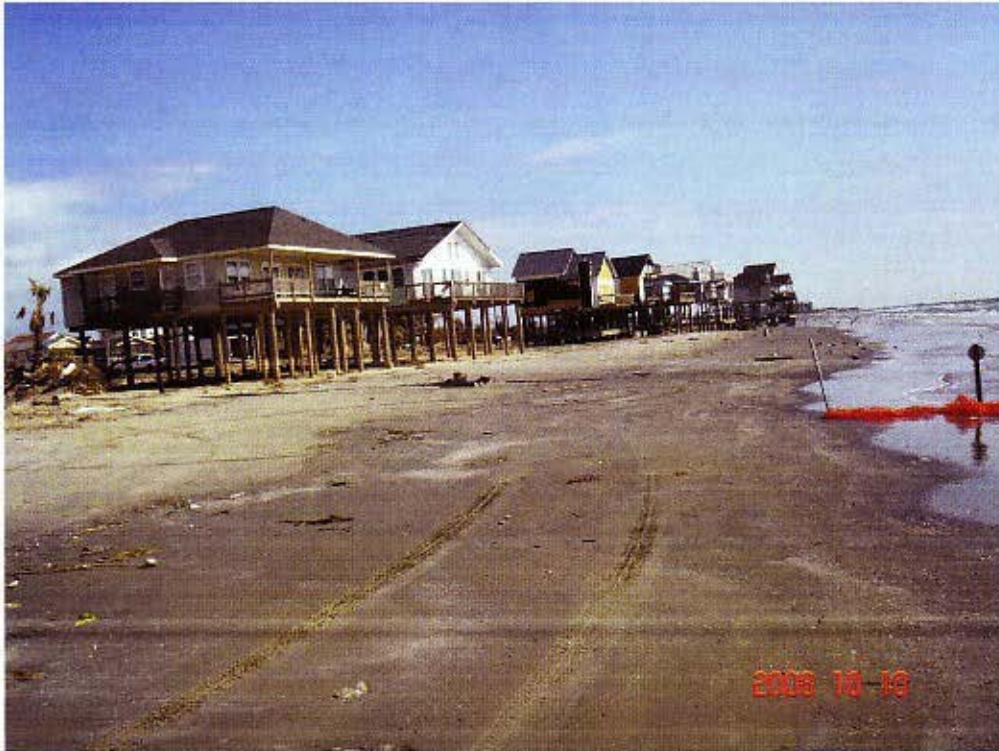
Figure 9. Post-Hurricane Ike photograph of narrow, slope less beach on West Galveston Island.

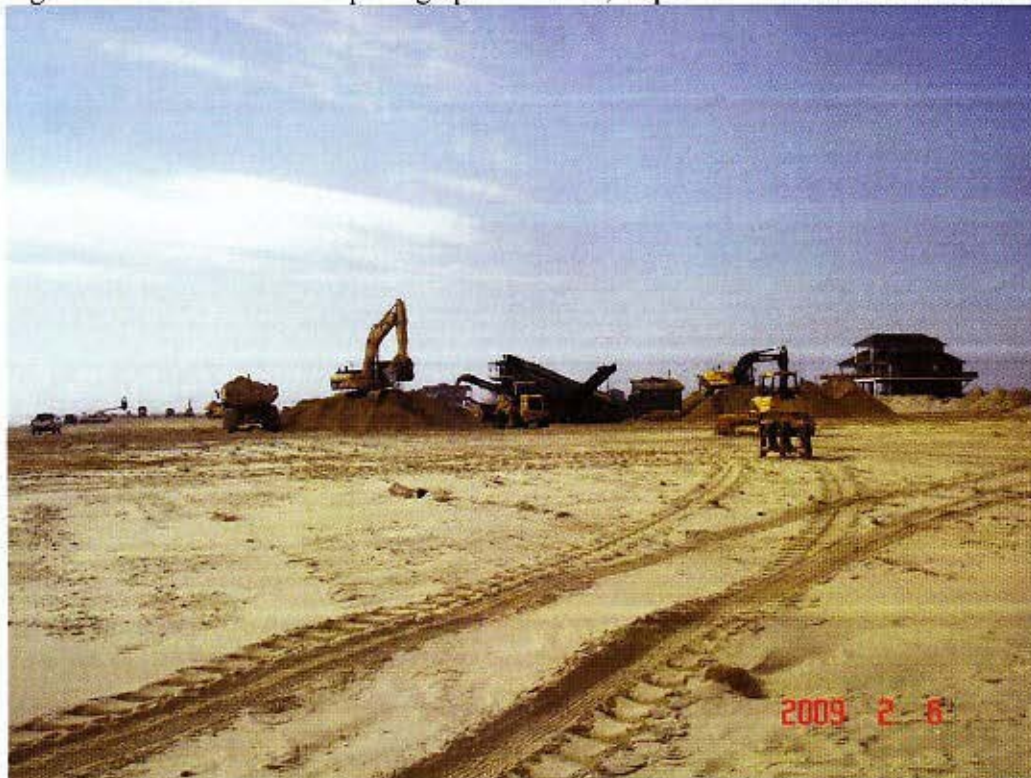
Figure 10. Typical storm debris cleaning site and heavy equipment used to transport sand on Bolivar Peninsula.

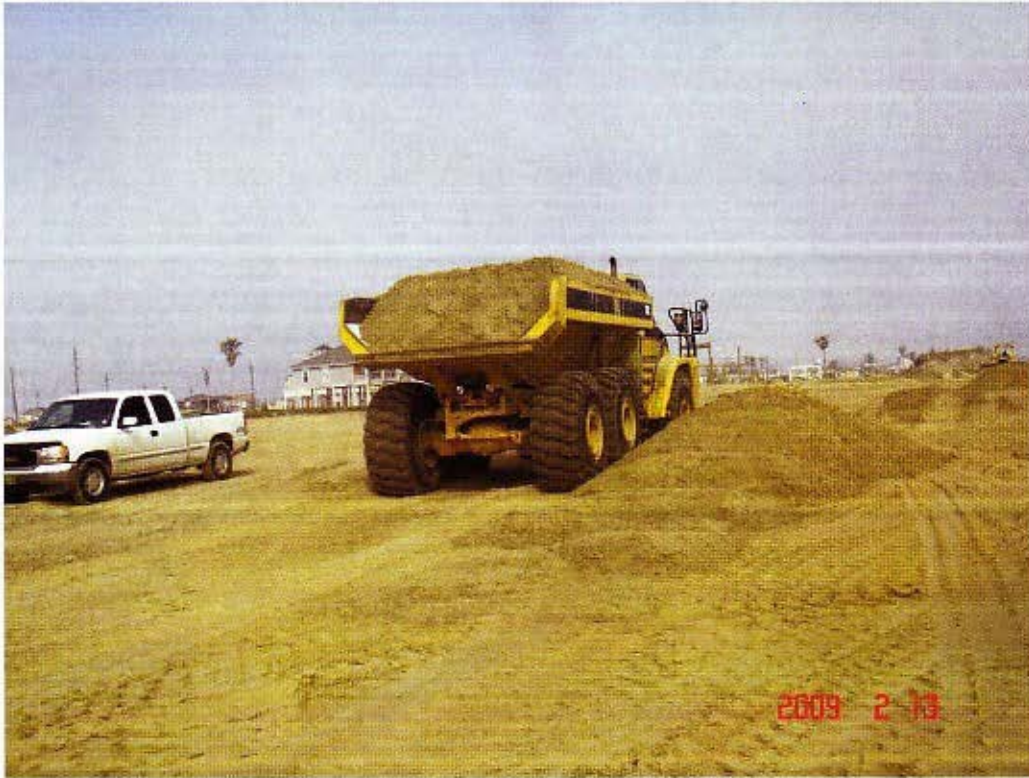
Figure 11. Heavy equipment used to transport clean sand used in renourishing Bolivar Peninsula and Galveston Island beaches.

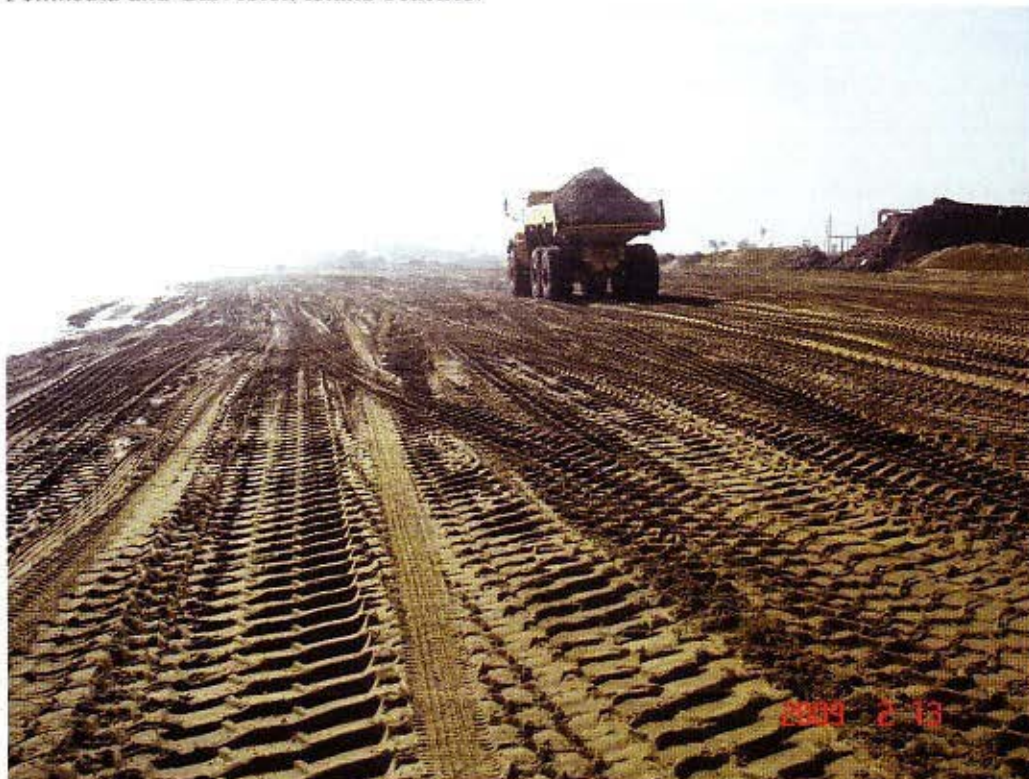
Figure 12. Bolivar Peninsula beach exhibiting highly compacted sand substrate as a result of heavy equipment used in renourishment activities.

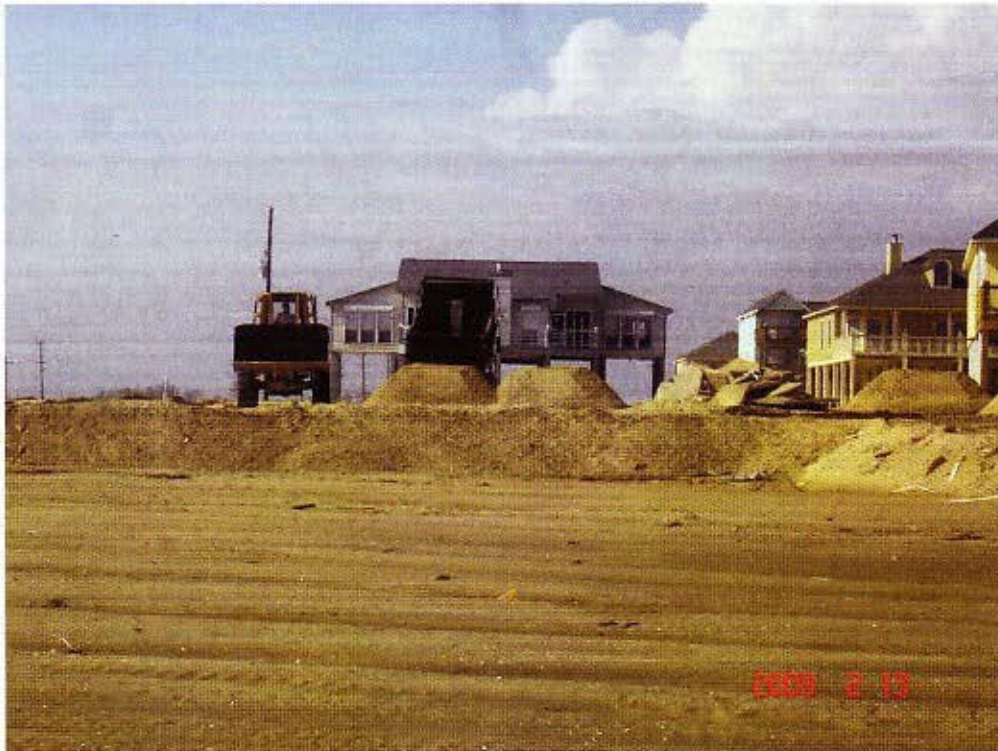
Other efforts include individual homeowners and subdivision associations ignoring GLO's prohibition by paying private contractors to recapture sand from their lawns and adjacent streets (Fig. 13) as well as truck in other non-sandy soils for placement on beaches, where it is typically put upland of its pre-like dune location. Loss of sand and GLO restrictions on its recovery have caused UTC home- and subdivision owners to use non-sandy sources (Fig. 14) that may increase the risk this replacement substrate does not exhibit the same physical and chemical characteristics of that washed away, thus rendering nest building and egg incubation problematic (Yanno and Slutzman, 1992). In addition, various "sand-catching" initiatives, including recycled Christmas trees tethered together in rows parallel to the beach as well as large, hay bales stacked against one another in similar rows (Figs. 15 and 16), designed to expedite the development of dunes are being deployed by homeowners on both Bolivar Peninsula and West Galveston Island. Many of these sand-catching initiatives have been in place on the aforementioned beaches with little evidence that measurable quantities of sand, much less actual dunes, have materialized.

Figure 13. Private contractors recovering sand from homeowners' yards in the rebuilding of dunes on Bolivar Peninsula.

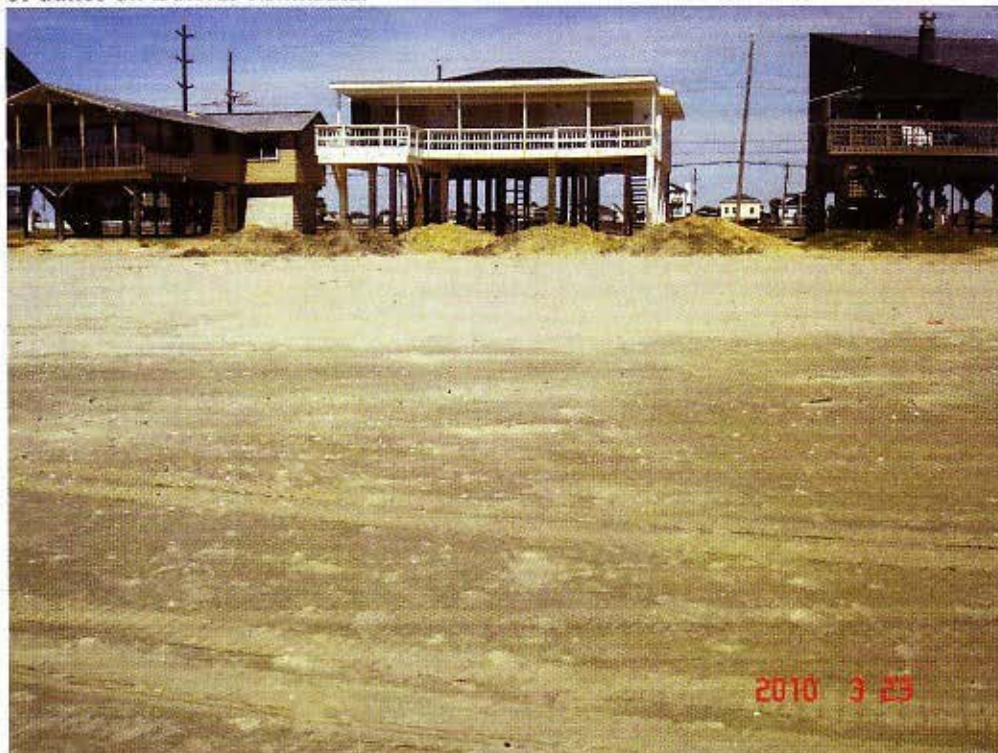
Figure 14. West Galveston Island site where non-sand substrate(s) is used as a dune renourishment initiative.

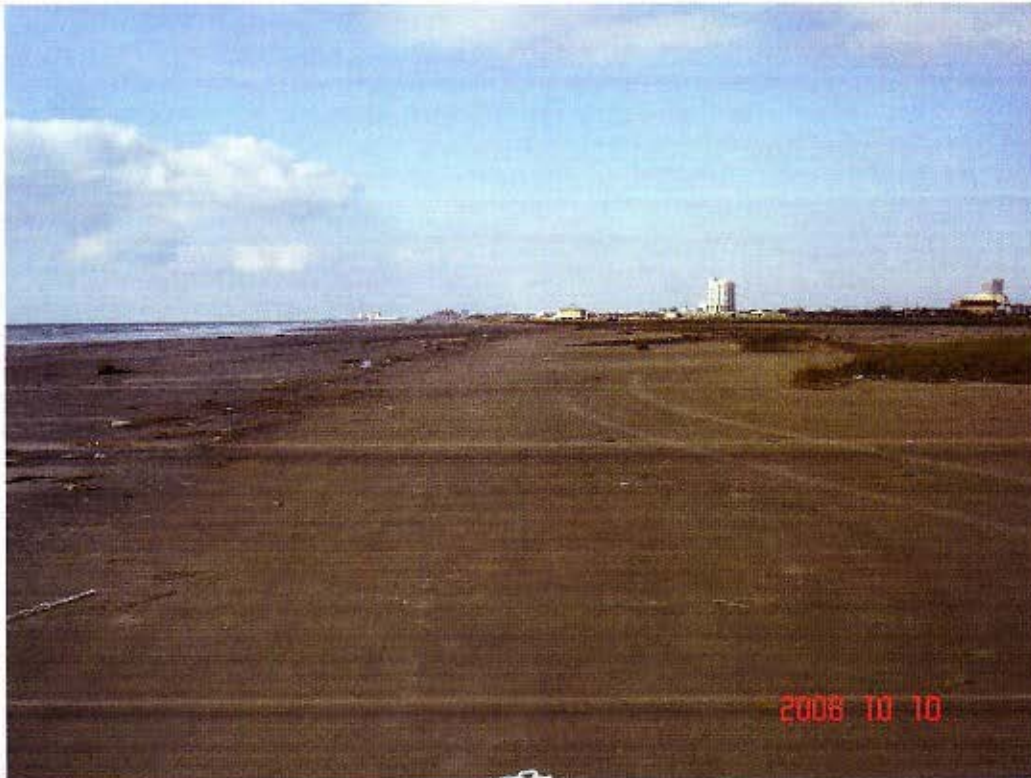
Figure 17. Post-Hurricane Ike photograph of a wide, heavily storm-scoured, compacted beach on Galveston Island.

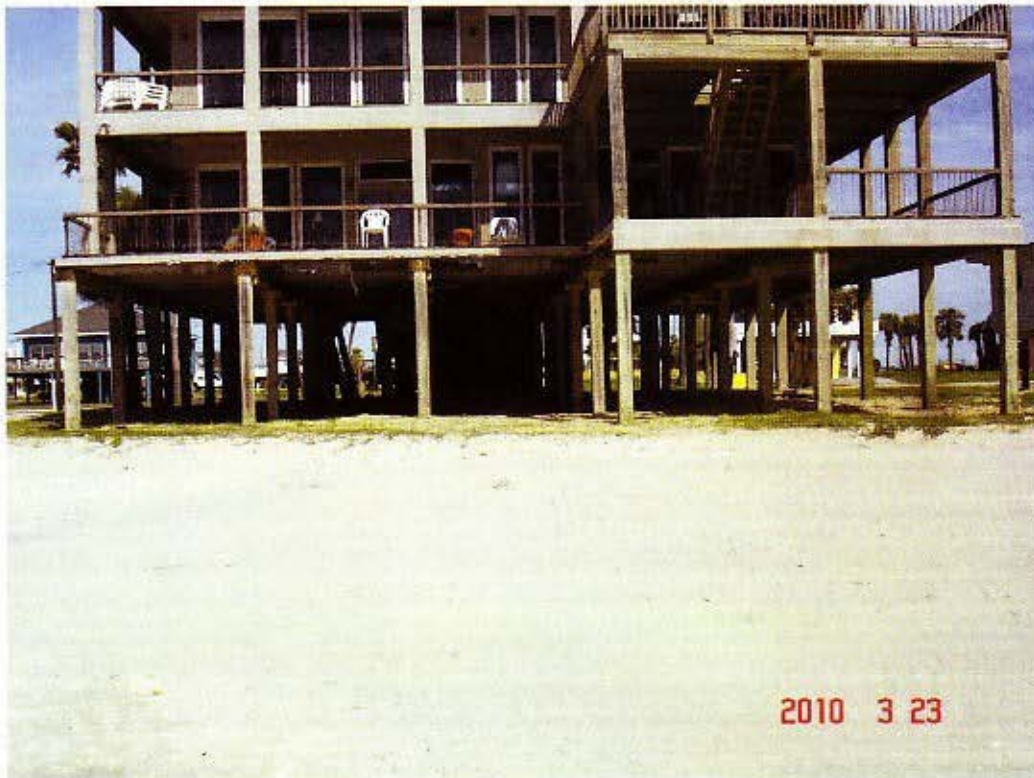
Figure 21. Example of beach habitat devoid of dune development on West Galveston Island.

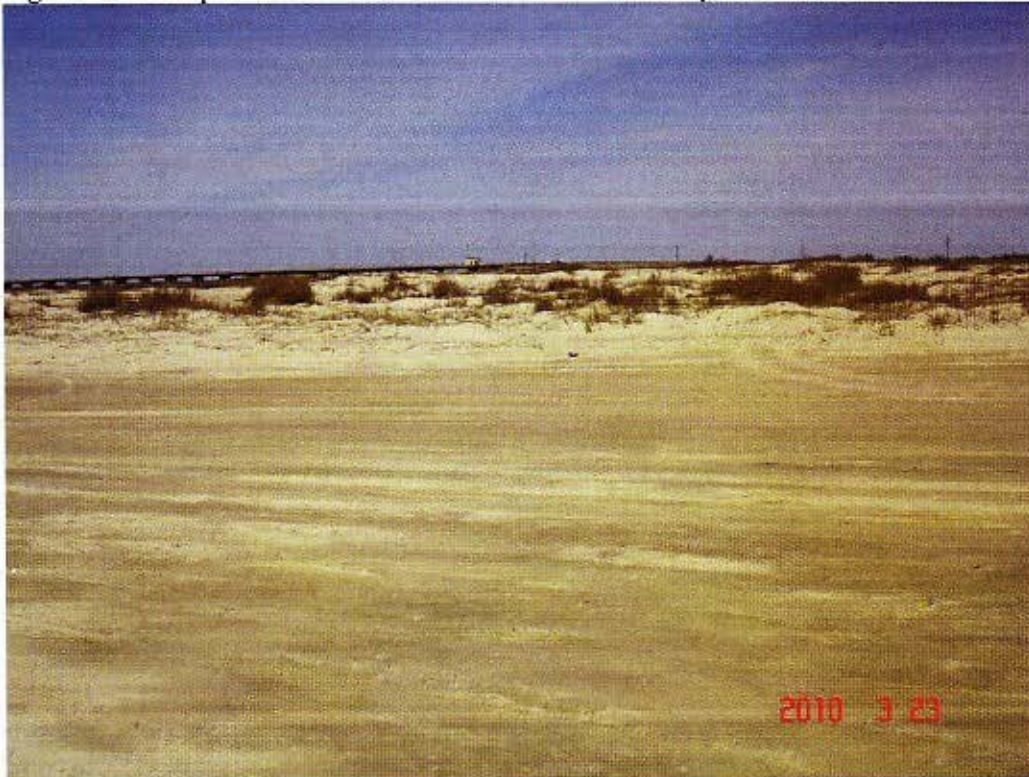
Figure 22. Fairly well developed sand dunes on accreting beaches near San Luis Pass.

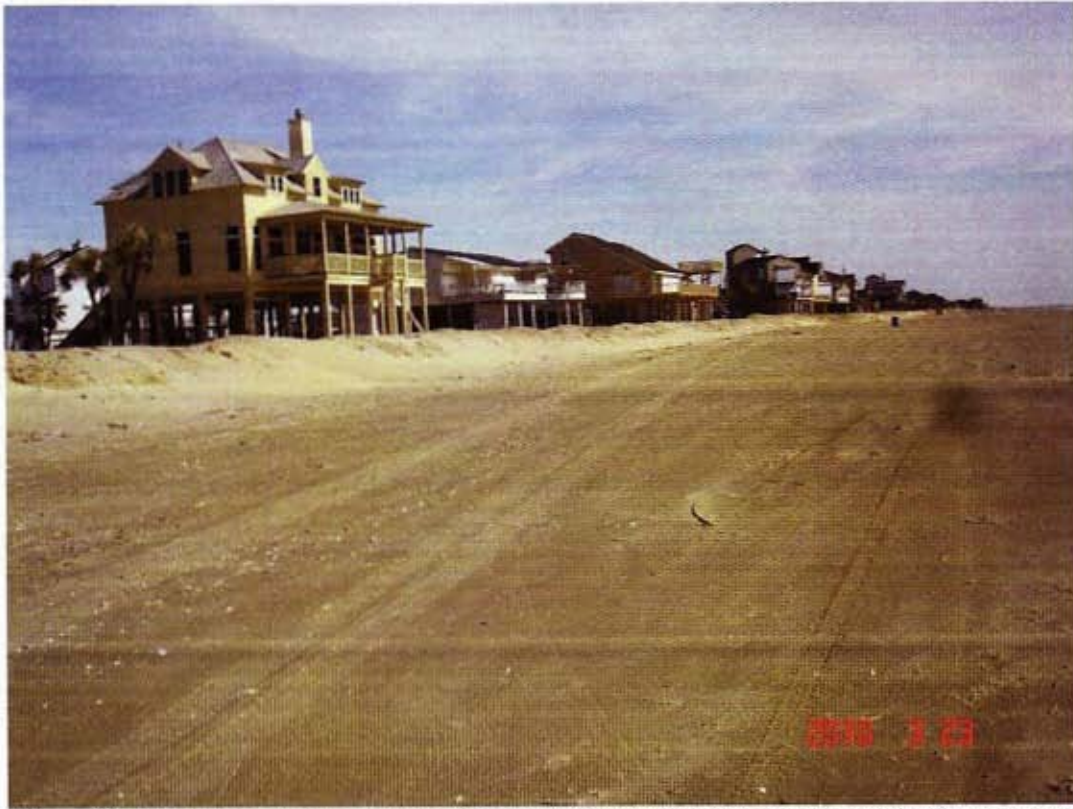
Figure 23. Sand dunes lacking vegetative cover and dune crossovers on West Galveston Island.

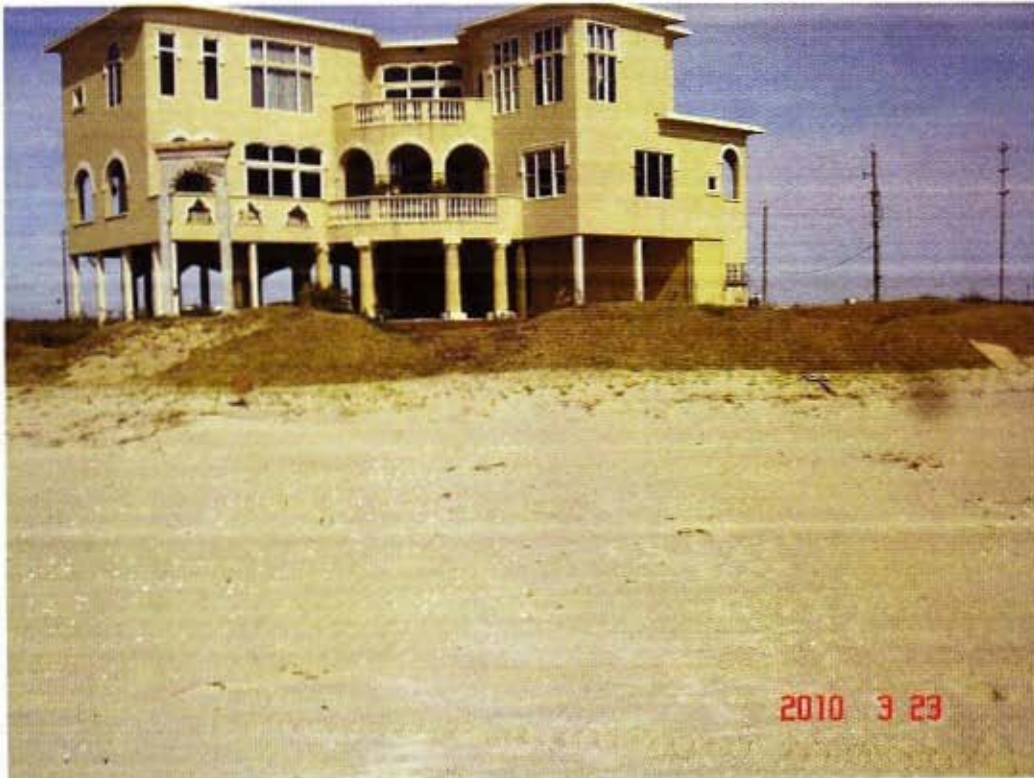
Status of Sand Dunes: Presence and absence of sand dune development along the UTC varies from total lack of embryonic dunes on eroding beaches (and lack of effort on the part of a homeowner or subdivision; Fig. 21) to fairly well developed dunes on accreting beaches such as those near San Luis Pass (Fig. 22). Dunes that do exist on the UTC exhibit varying degrees of vegetative cover ranging from no emergent plants (Fig. 23) to complete coverage by emergent plants (Fig. 24). Vegetative cover on other dunes is often comprised of salt-sensitive species such as St. Augustine grass (Fig. 25) that will

Figure 25. Sand dunes covered with salt sensitive St. Augustine grass on West Galveston Island.

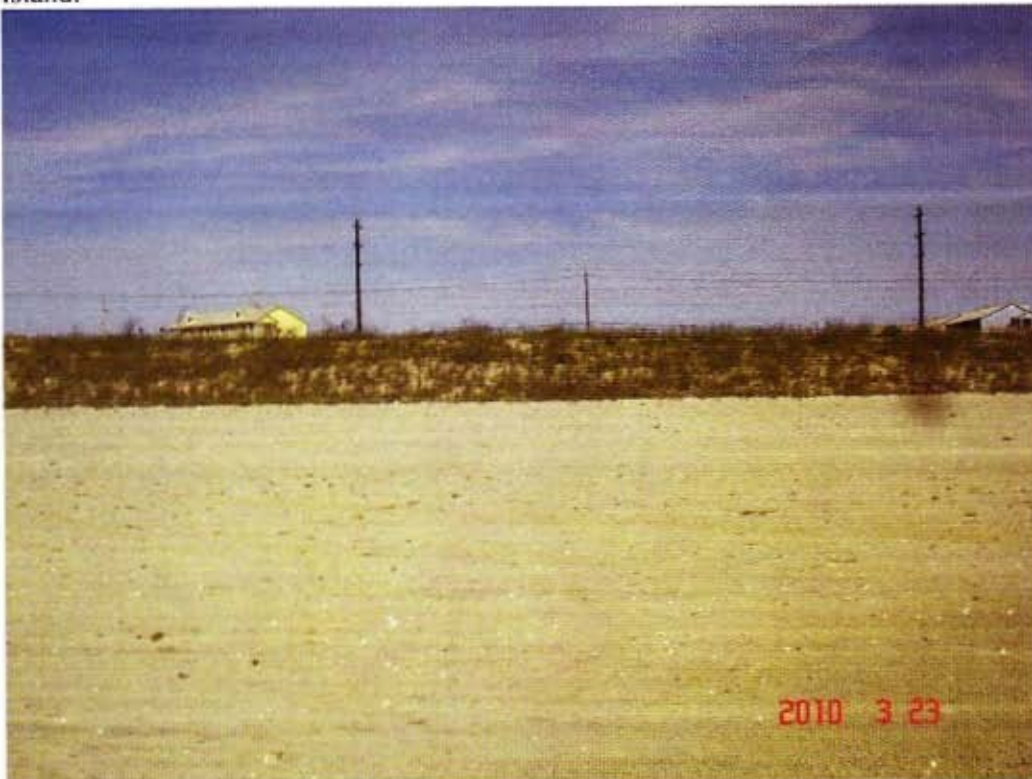
eventually die, thus leaving the dune with little supporting integrity. There are several well designed dune complexes on West Galveston Island that are covered by a variety of salt tolerant vegetation (Fig. 26).

Figure 26. Well designed sand dune with salt-compatible vegetative cover on West Galveston Island.

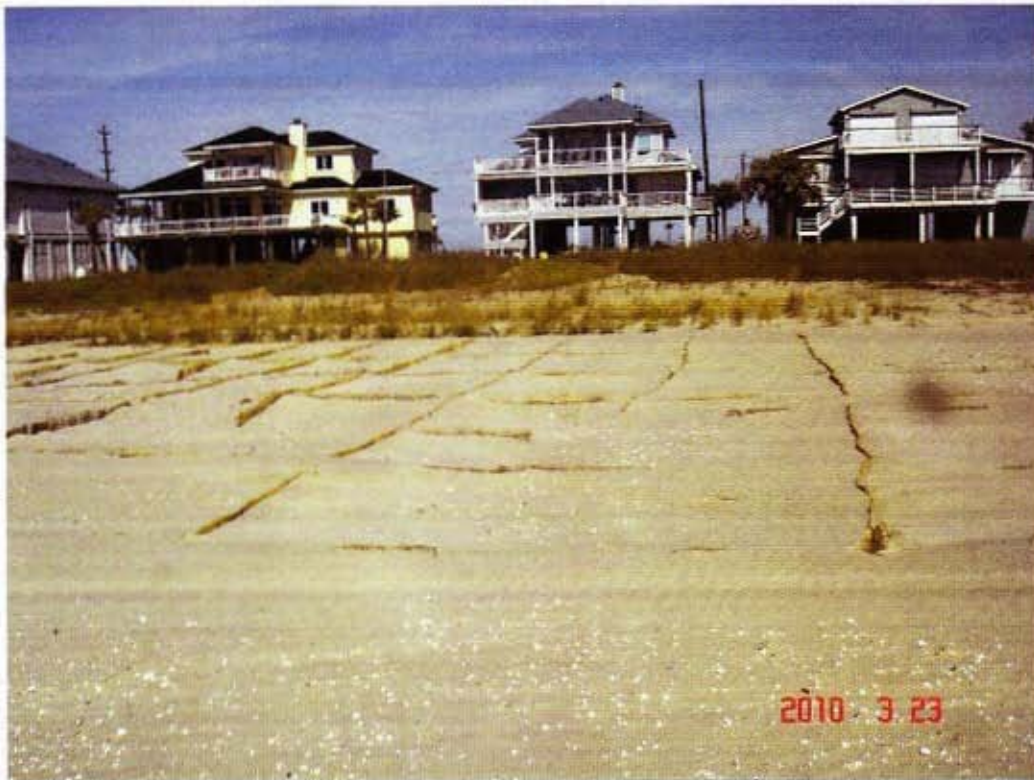
Figure 29. Assortment of sand accreting features including perpendicular and parallel fences bordering rows of planted vegetation on West Galveston Island.

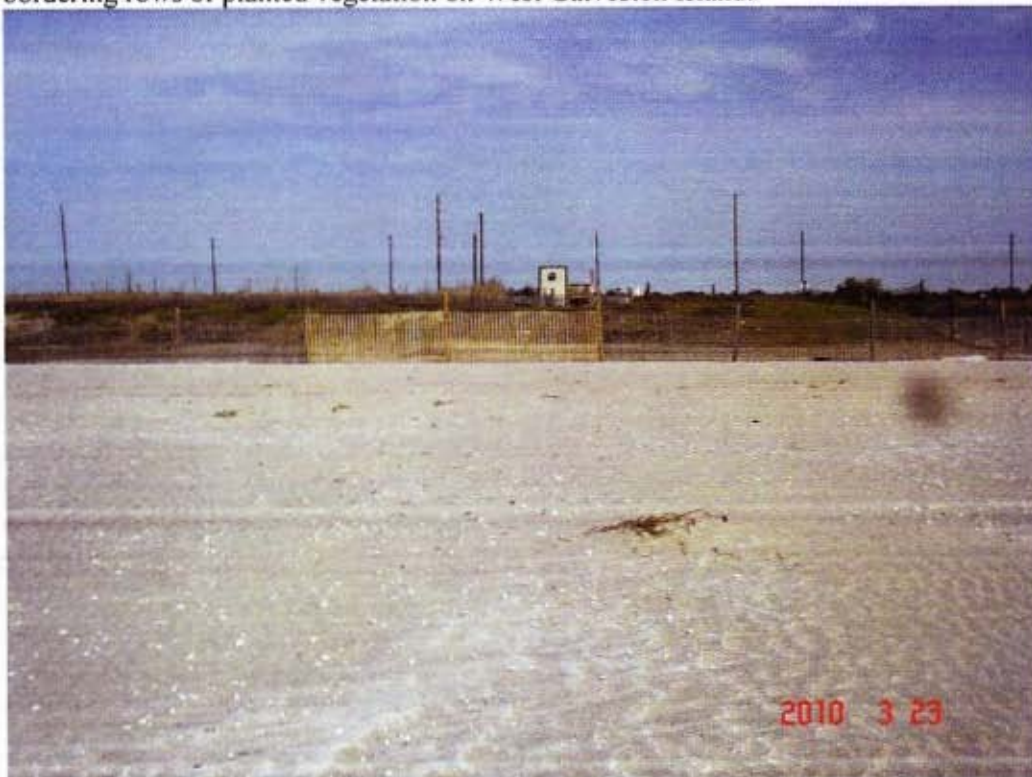
Dune Building/Renourishment: Like those for vegetative cover, dune building/renourishment activities on the UTC exhibit a wide array of sand accreting protocols. One of these is the sand fence protocol of catching sand and protecting developing dunes. Although numerous sand fences have been erected on West Galveston Island, very few exhibit the angled orientation (Fig. 27) compatible with accreting sand as well as enabling nesters and hatchlings to move freely from beach to dune or dune to beach. Variations off this design are open fences oriented perpendicular to the dune line (Fig. 28), some of which are bordered by planted vegetation between the fence and intended dune line (Fig. 29). These variations in sand fence design and placement are novel and must be evaluated in their ability to build dunes in a sea turtle compatible manner. The majority of sand fencing seen on West Galveston Island is the "turtle unfriendly" design running in a continuous, parallel fashion without breaks that would allow free passage of nesters and hatchlings (Fig. 30).

Figure 30. Solid line of closed sand fencing oriented parallel to dunes on West Galveston Island.
