Final Report:
Freshwater Inflow Standards for East Matagorda Bay Wetlands: Lake Austin

Texas Coastal Management Program, Texas General Land Office Contract #23-020-006-D600

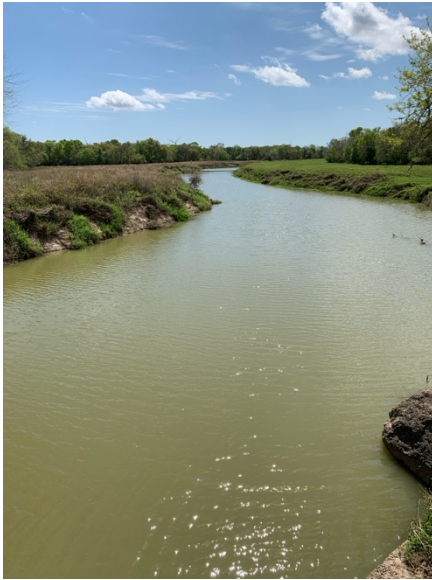
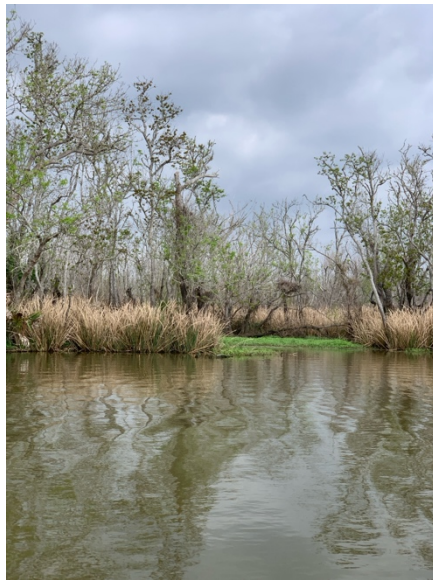
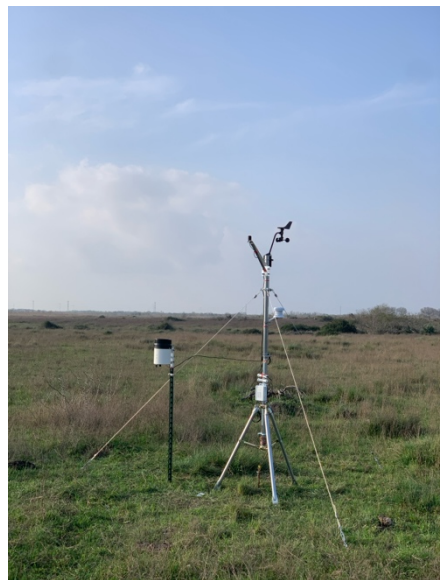
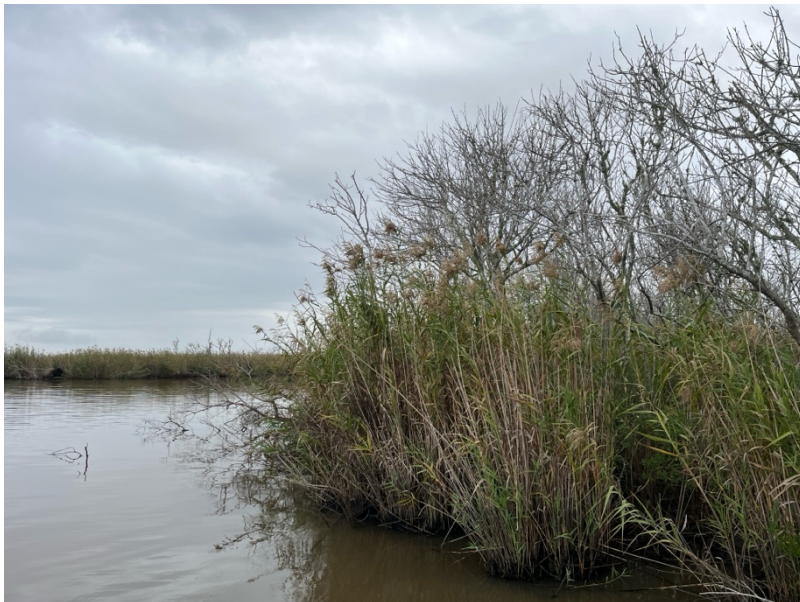
Fig. 2. Upper portion of Peyton Creek (PC) near Highway 171 (upper left), middle lower portion south of 521 (upper right), and a typical coastal prairie in the Peyton Creek sub-watershed area (upper right).

Lower portion of Peyton Creek where it intersects with Lake Austin (lower left).

Peyton Creek (PC) drains the northern and western portions of the Lake Austin watershed and flows directly into Lake Austin on its northwest side (Fig. 2). It is surrounded by a coastal prairie mosaic with farm and pastureland. Upstream near Bay City, many drainage ditches lead into smaller tributaries that themselves lead into PC. These smaller tributaries include Cottonwood Creek, Dry Creek, and Bucks Bayou (Fig. 3). Further downstream, many irrigation canals ferry water from the nearby Colorado River across the landscape to rice and crawfish farms. These farms then drain into ditches, which lead to Live Oak Creek and Wadsworth Slough, which then themselves flow to PC.

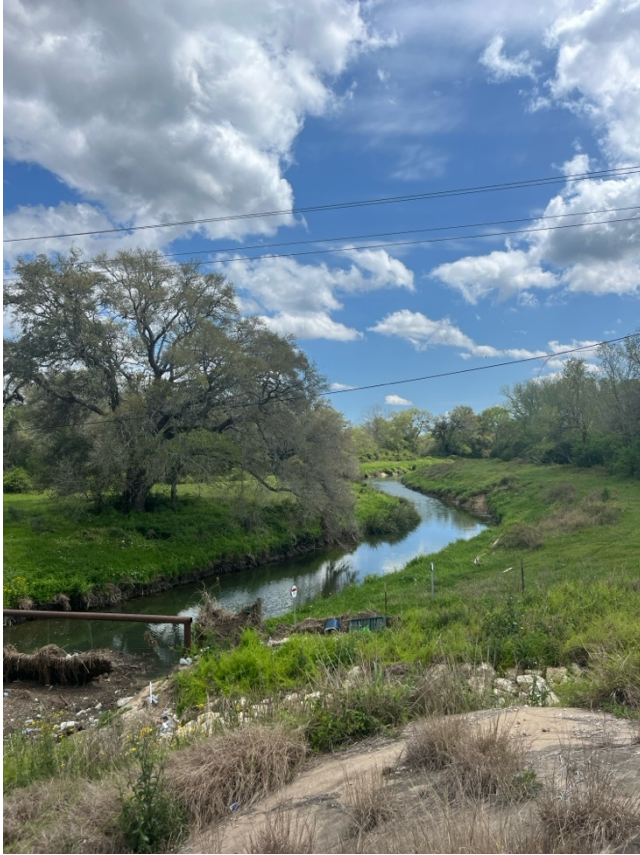
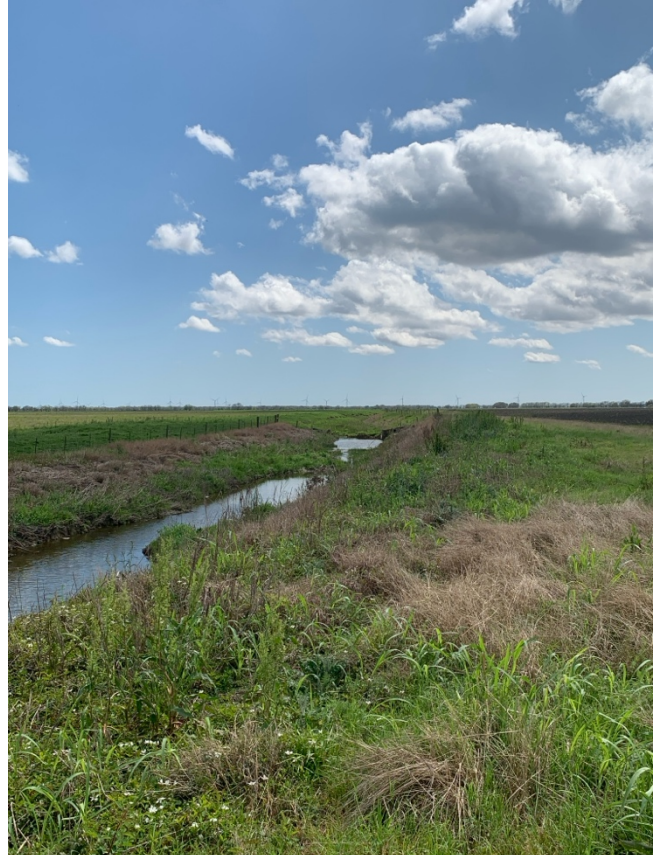
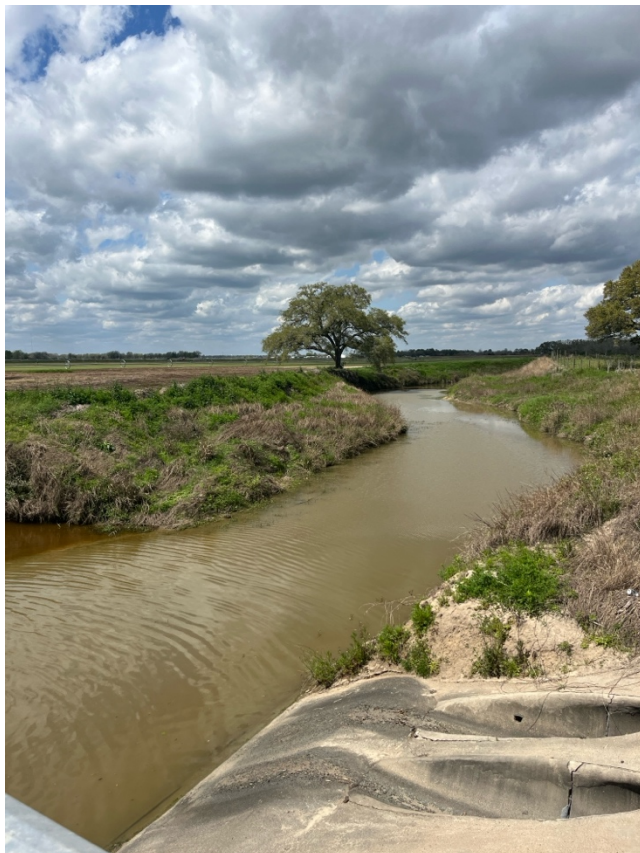
Fig. 3. Cottonwood Creek (upper left), Dry Creek (upper right), and Bucks Bayou (lower left). All of these tributaries are upstream of Peyton Creek and flow into it.

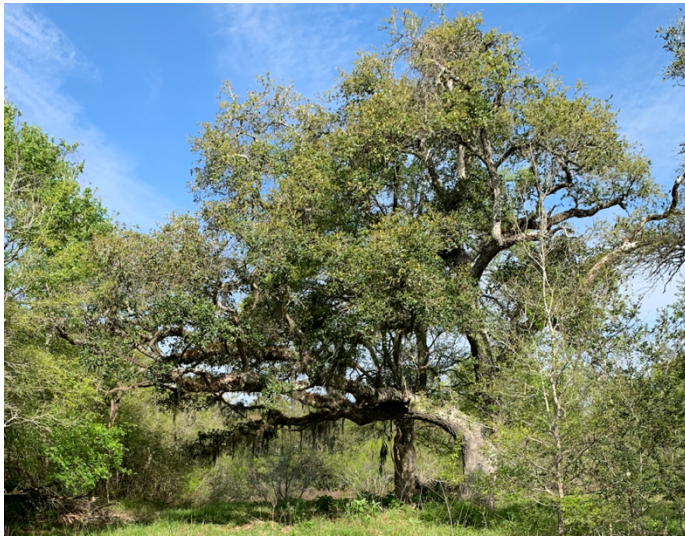
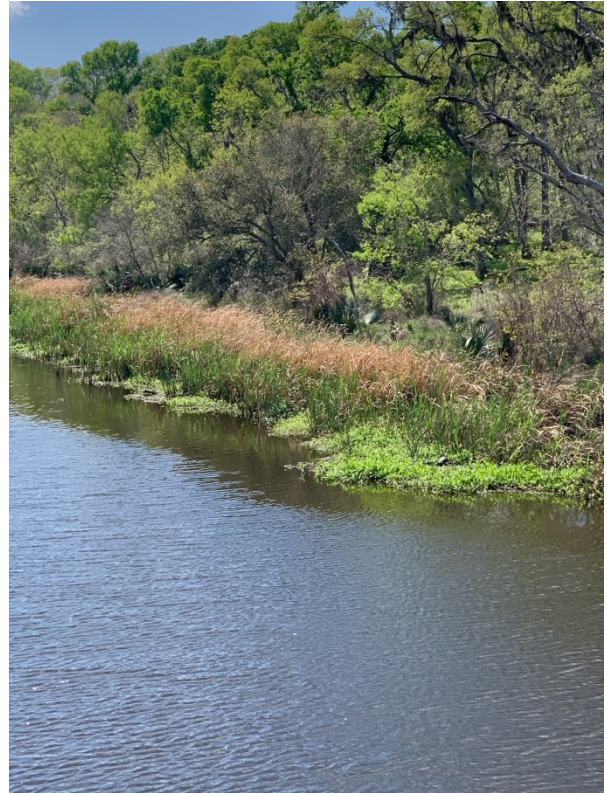
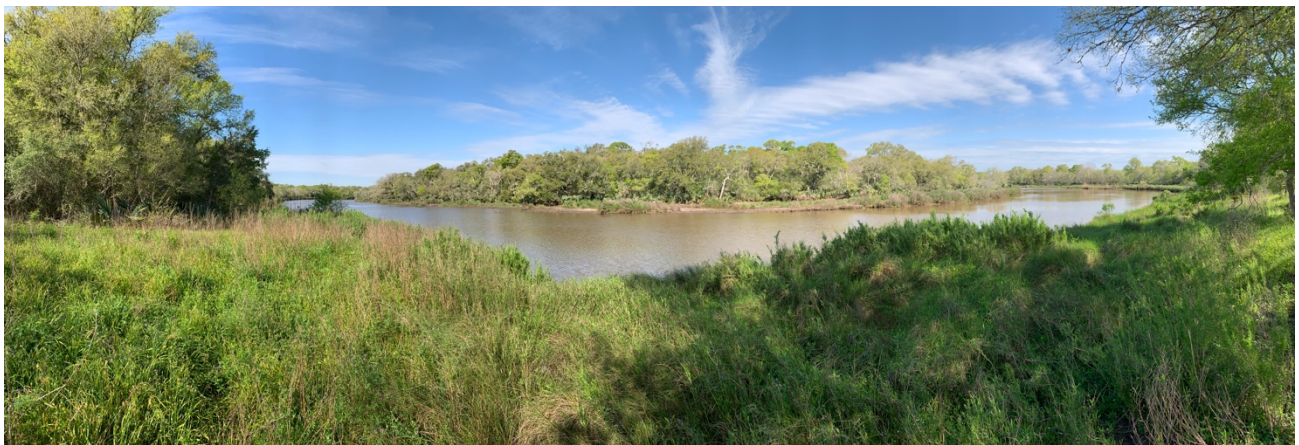
Fig. 4. Upper portion of Live Oak Bayou (UL portion) near 521 (upper right), and middle portion in the San Bernard NWR near Hawkins Road (below and bottom).

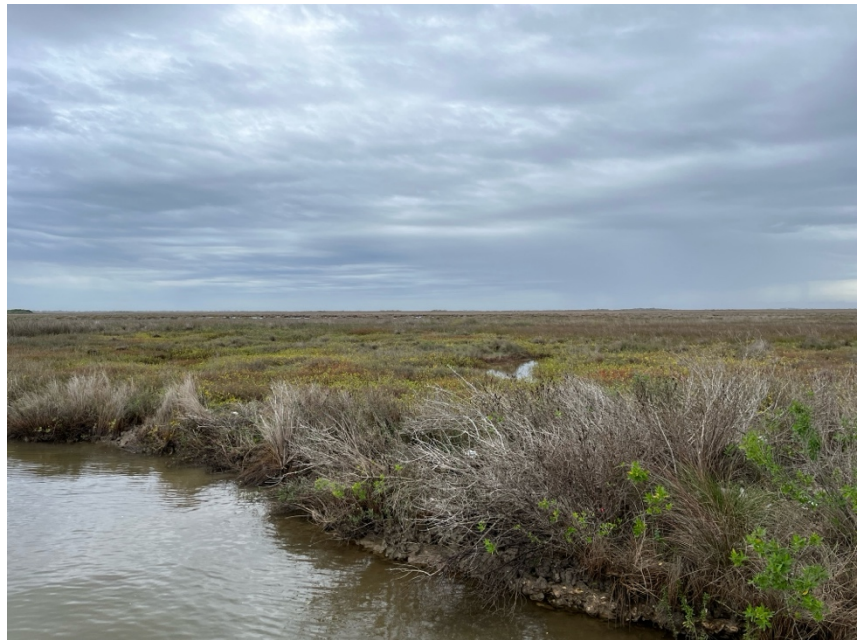
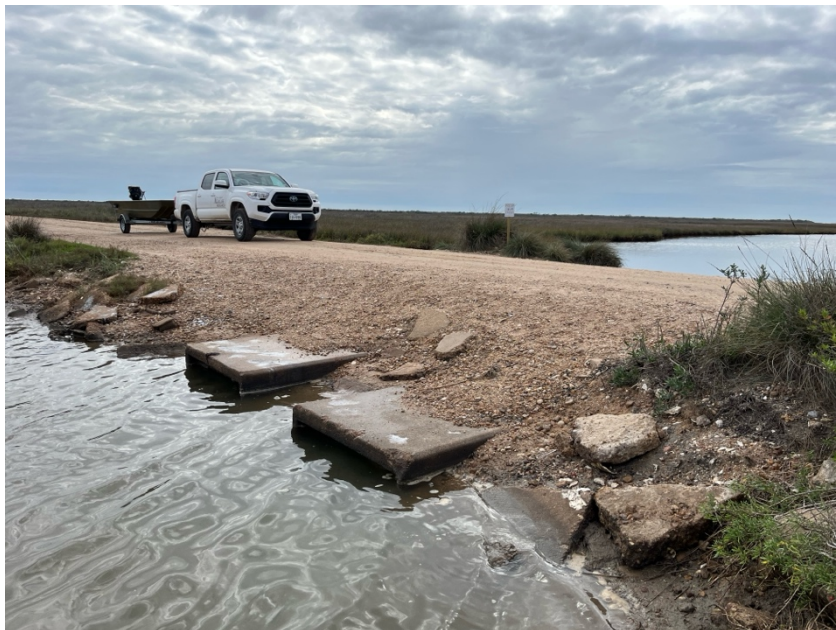
Fig. 5. Salt marsh near the intersection of Live Oak Bayou (LO) and Chinquapin Bayou (CB) (right).

Downstream of Lake Austin, the landscape is composed of salt marsh (Fig. 5; we refer to this portion of Live Oak Bayou, that passes by a small fishing community, as LO). Chinquapin Bayou (CB) meanders through the marsh on the western side of LO and drains to LO. A gravel road, Chinquapin Road, forms the western boundary of the Lake Austin watershed, near CB and LO. A separate watershed, the Big Boggy Creek watershed, connects through a culvert under this road and across the watershed boundary (Fig. 6). The Big Boggy Creek watershed contains the USFWS Big Boggy NWR and Pelton Lake (PL). A portion of the Big Boggy NWR also lies on the Lake Austin watershed side, in the area immediately surrounding CB.

The Lake Austin watershed connects with the adjacent Big Boggy Creek watershed through culverts that go under Chinquapin Road (below). This location connects between our Chinquapin Bayou (CB) and Pelton Lake (PL) stations.

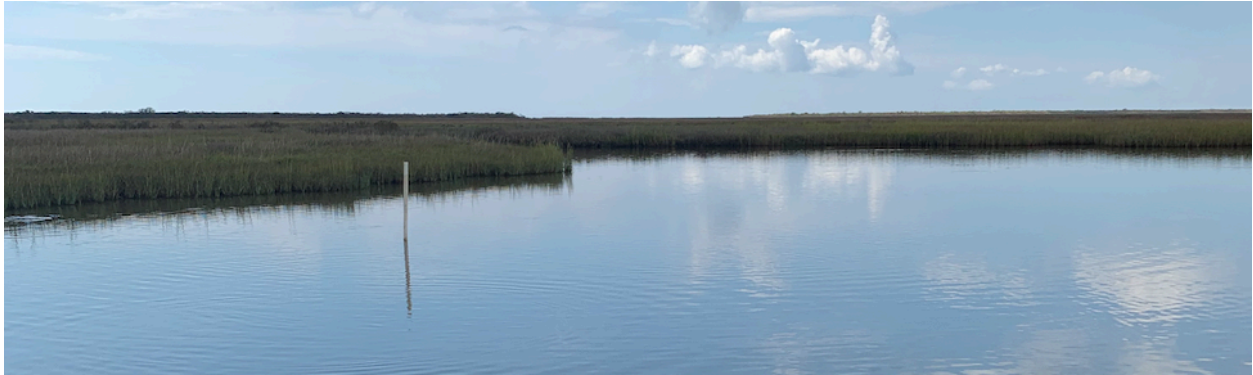
Fig. 6. The CTDs were installed inside of PVC pipes and placed into water bodies or channels.

The CTDs contained a pressure sensor that measured the hydrostatic pressure of the water, as well as a conductivity sensor that measured the specific conductivity of the water in millisiemens (mS). Conductivity is a standard proxy for salinity. The CTDs were set to record measurements hourly. They were deployed in a PVC pipe securely inserted into the bottom of the water body or channel, with slits in the pipe allowing for water to exchange freely (Fig. 6).

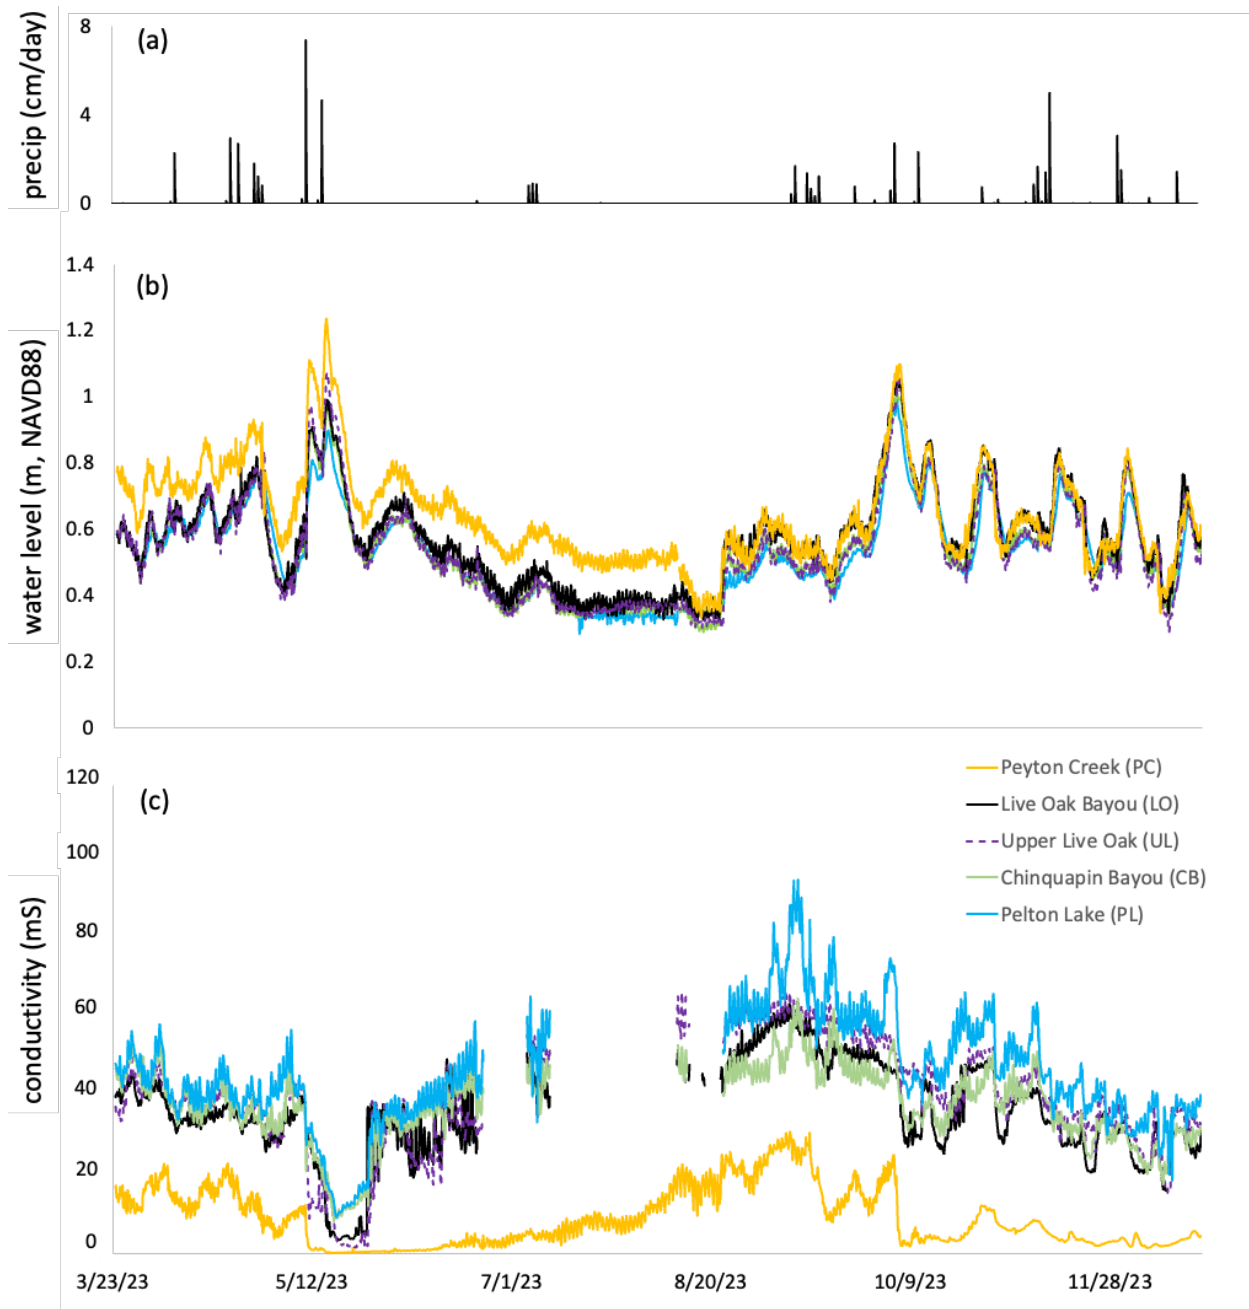
Fig. 9. (a) Precipitation, (b) water level, and (c) conductivity from 03/23/23 to 12/22/23 at the Lake Austin sensor stations.

Still, the water level and salinity at all five of the stations were affected by both precipitation events and by tides (Fig. 9). When it rained heavily, the water level rapidly increased and the conductivity dropped at all stations. During a long drought that occurred in the summer, the water level decreased and conductivity greatly increased at all stations.

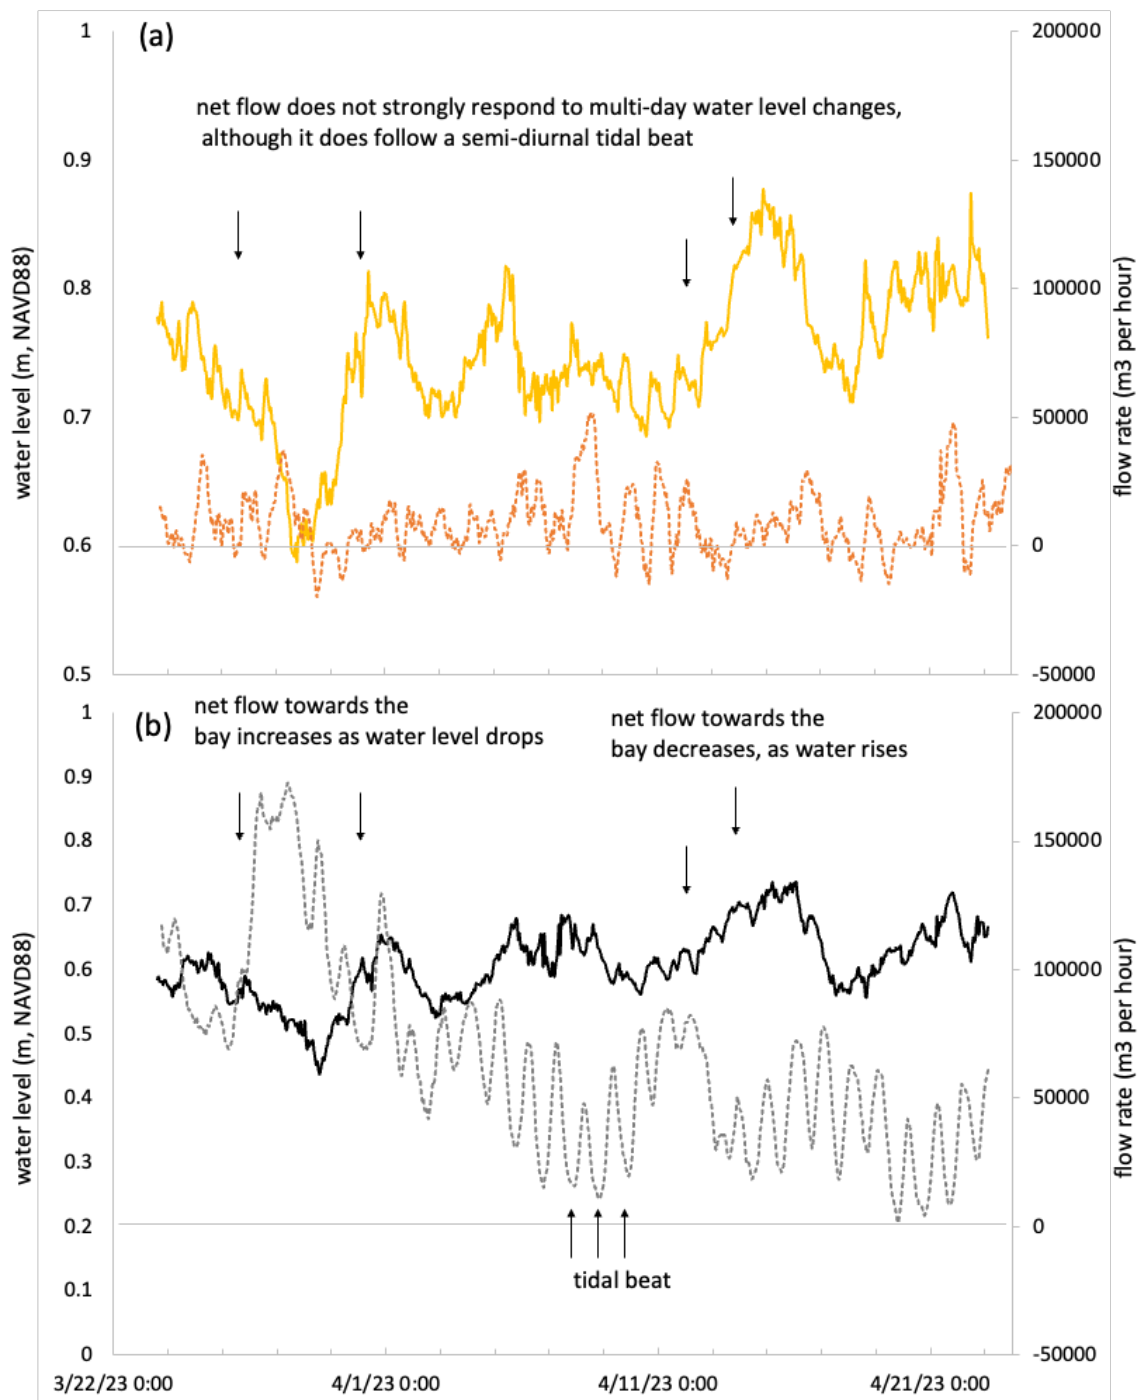
Fig. 12. Water flow rate and water level from 03/23/23 to 04/23/23 at (a) Peyton Creek (PC), and (b) Live Oak Bayou (LO). Positive flow rate indicates downstream movement, negative indicates upstream.

In terms of the freshwater volumes flowing into and out of Lake Austin, PC was relatively low while LO was much higher (Fig. 12). Interestingly, the PC water level and flow rate followed a semi-diurnal tidal beat and flowed both upstream and downstream, but it did not follow multi-day wind tides (e.g., 03/23/23 to 03/21/23). Still, its flow spiked after large precipitation events on 05/11/23 and 05/14/23 (Fig. 13). Strangely and in opposition, the LO water flow rate followed both a semi-diurnal and multi-day wind tidal beat, yet its flow direction was always going downstream towards the bay during the period of record.

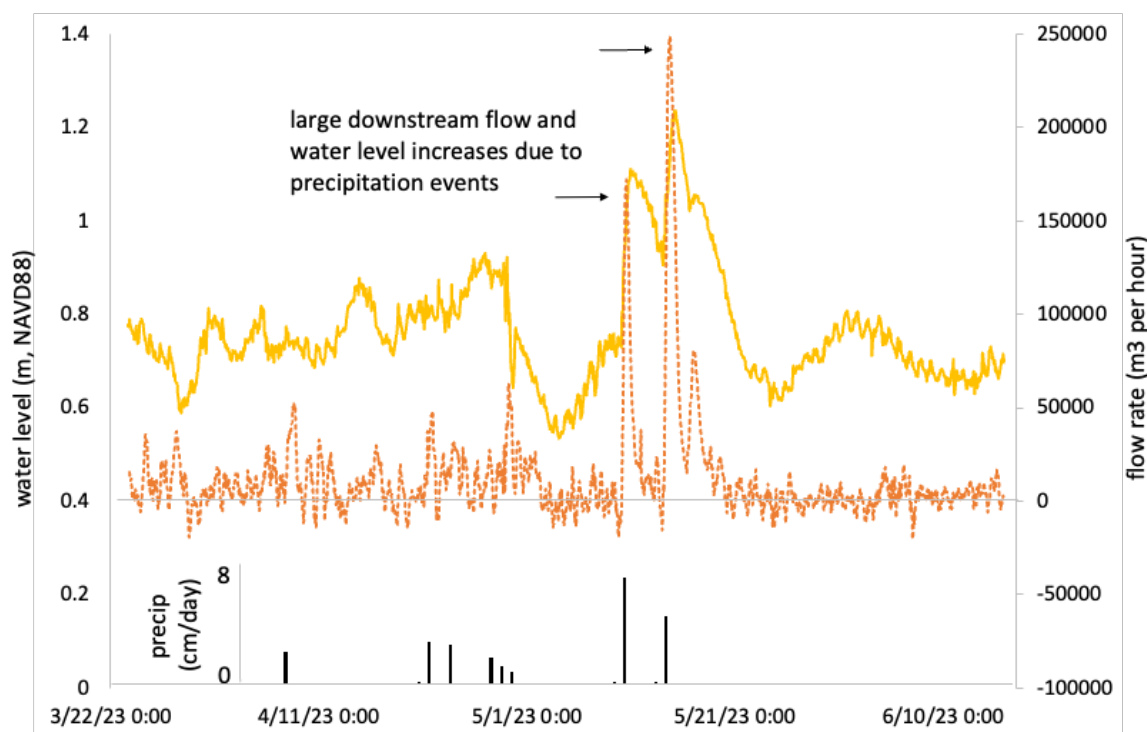
Fig. 13. Water flow rate, water level, and precipitation from 03/23/23 to 06/15/23 at Peyton Creek (PC). Positive flow rate indicates downstream movement, negative indicates upstream.

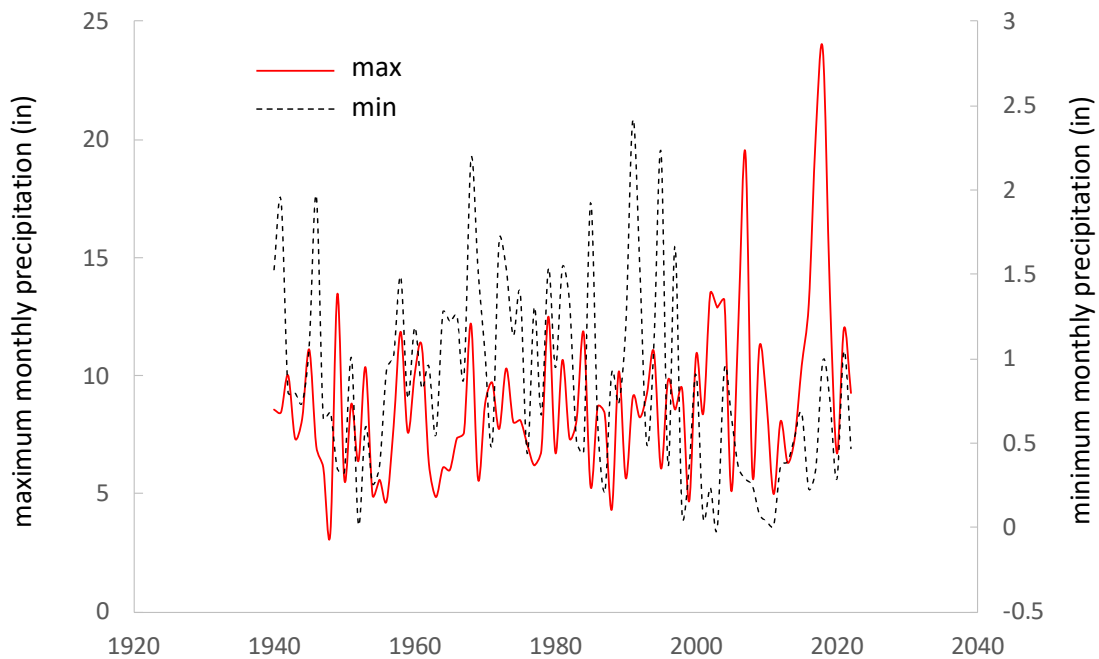
Fig. 20. The Lake Austin watershed has experienced both an increase in the maximum monthly precipitation it receives during any one year, and a decrease as well. In other words, today it is having more extreme wet months and dry months, as compared to the past years. Data from Texas Water Development Board (2024).

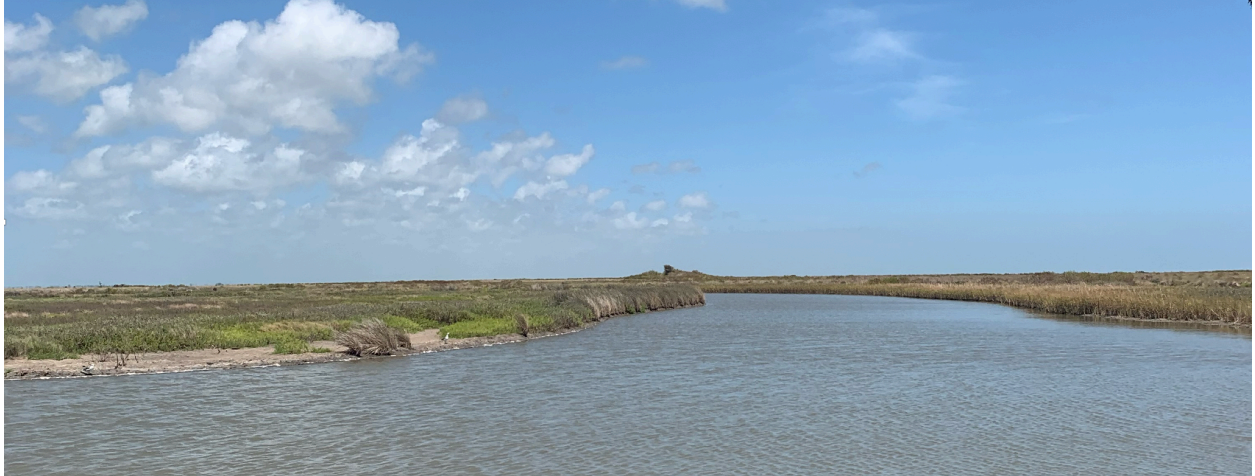
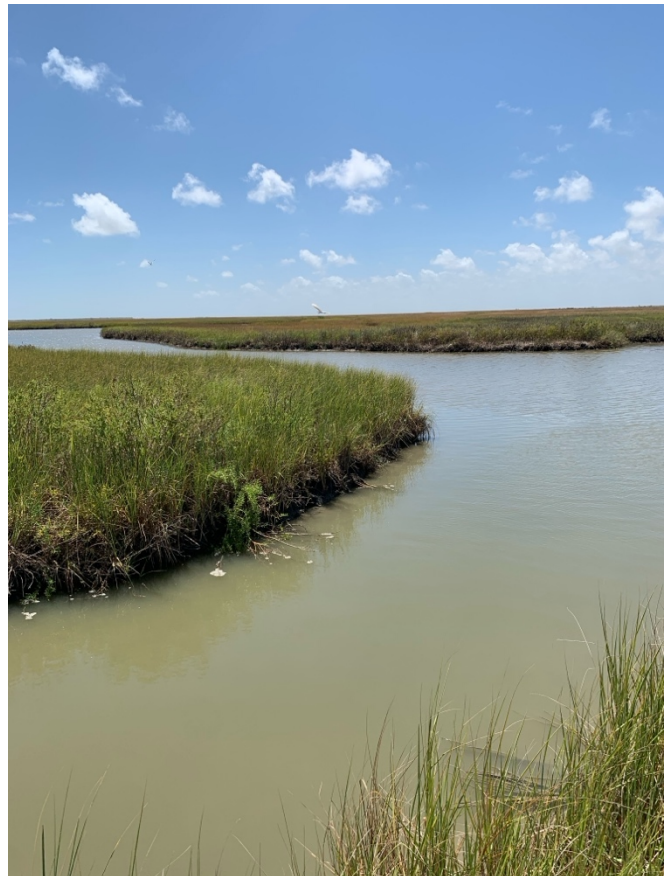
Fig. 23. *Spartina alterniflora* salt marsh on Live Oak Bayou (near LO) during extreme drought in August 2023 (above).

Low water level near the Pelton Lake (PL) station (right). The water in this picture was hypersaline at the time it was taken, > 70 mS.

This study occurred during a particularly dry summer in 2023, and the water level and conductivity data showed that under such conditions, the connectivity to freshwater sources greatly declined. Hypersalinity occurred and even the salt marsh plants suffered under conditions that were not suitable for growth (Fig. 23).

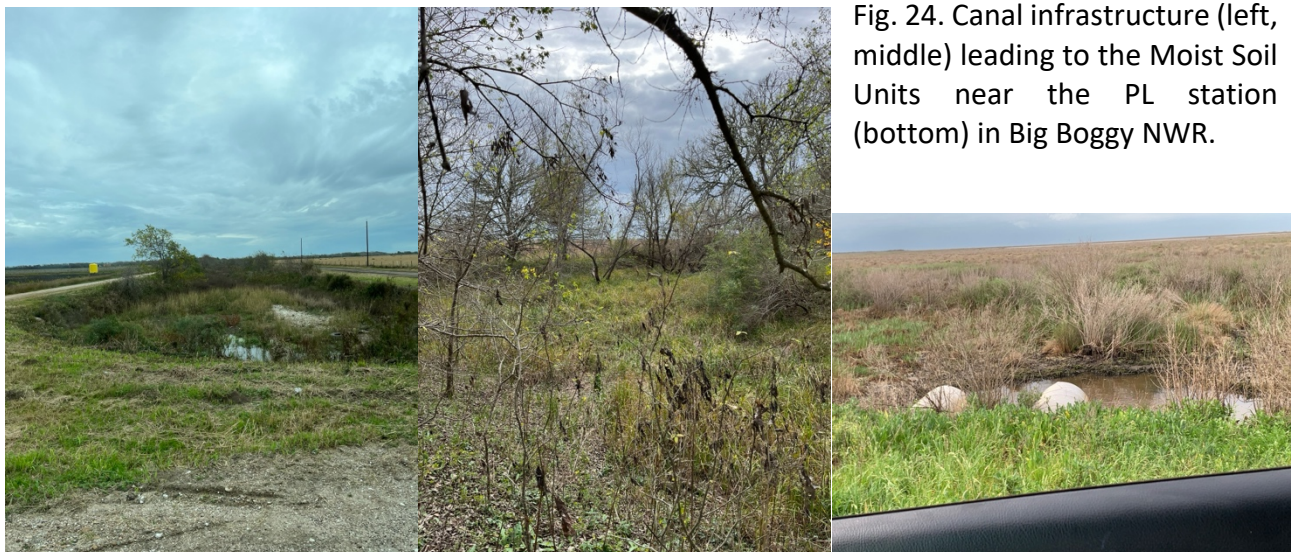
Fig. 24. Canal infrastructure (left, middle) leading to the Moist Soil Units near the PL station (bottom) in Big Boggy NWR.

The Texas Water Trade (TWT) is currently investigating such purchases and placing them into Moist Soil Units (MSUs) in Big Boggy NWR, immediately adjacent to the PL station at Pelton Lake. We investigated the quality of the MSUs and canals and communicated their status to TWT (Fig. 24). We additionally worked with TWT as they submitted a proposal to the Matagorda Bay Mitigation Trust (MBMT) to fund this water delivery.

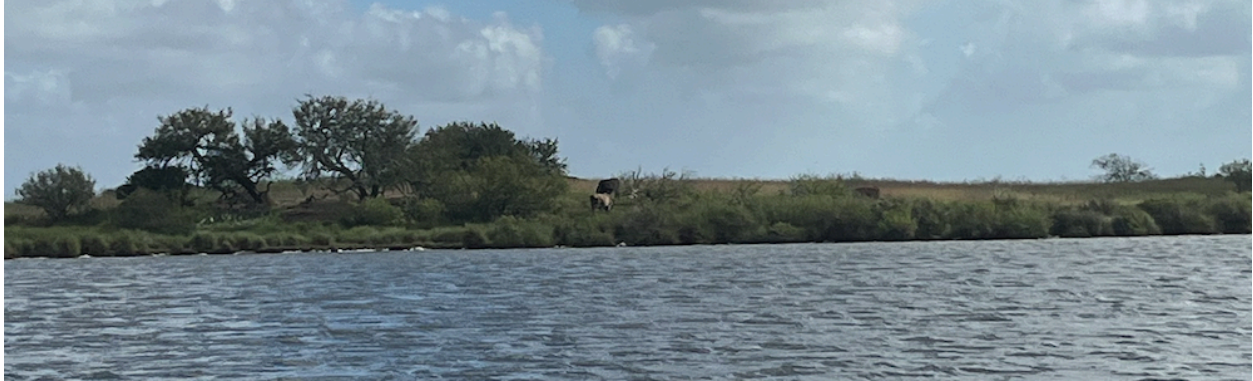
Fig. 25. Most of the Lake Austin shoreline does not have any wetlands. Rather, it is composed of an 1-2 m high embankment, backed by coastal prairie.

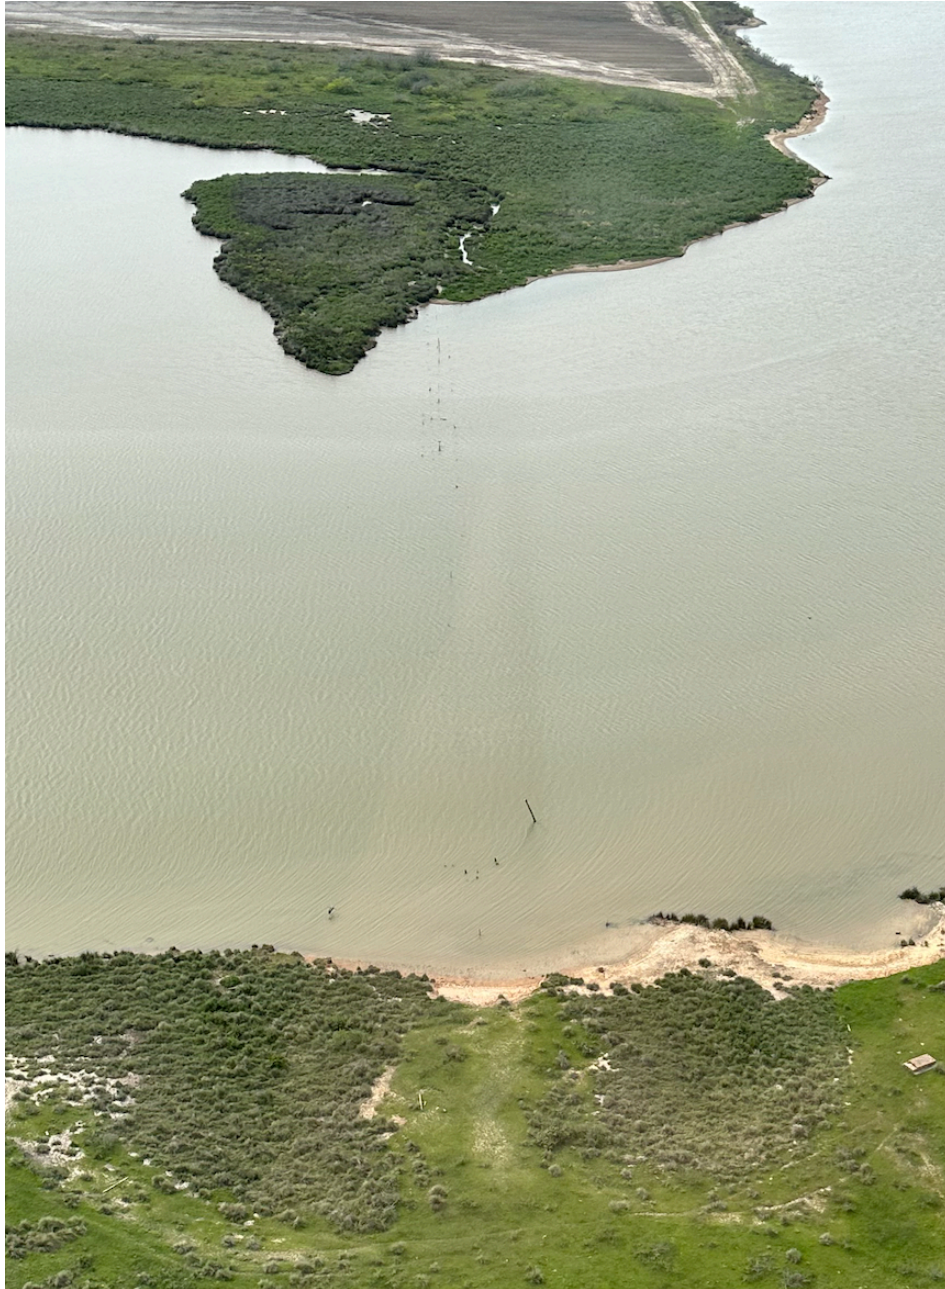
Many old pilings traverse the width of Lake Austin and impede recreational boat traffic (Fig. 27). While some of these pilings are visible, many lie below the water's surface. It is not uncommon for boats to hit these pilings and suffer damage. These pilings are remnants from an old bridge that crossed Lake Austin in its prior history.

Fig. 27. Pilings from an old bridge impede boat traffic in the central portion of Lake Austin. Photo graciously provided by Ryan Ashcraft, Ashcraft Aviation.

The removal of these pilings presents the best opportunity for work in Lake Austin and would provide the greatest immediate benefit for the local fishing community.

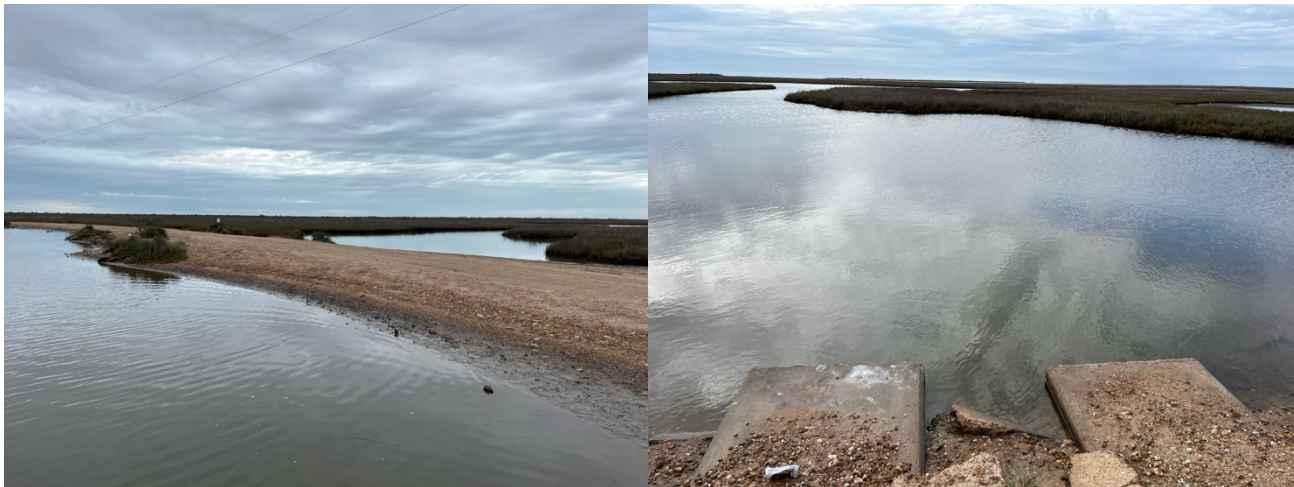
USFWS and TPWD have expressed concern that the hydrologic connection between the Lake Austin watershed and the Big Boggy watershed may be interrupted by Chinquapin Road. There are currently two culverts at this location (Figs. 5, 28), but it has long been a question about whether they provide sufficient flow. Madewell et al. (2021) was unable to fully address this question due to sensor failure.

The present study shows that the culverts appear to provide adequate flow (as shown by the data from the CB and PL stations) even during extreme summer drought conditions. The water level was still relatively high in them during the drought (Figs. 5, 28). Still, Pelton Lake at the PL station, and likely the eastern side of the large marsh complex in the Big Boggy NWR, suffered from hypersalinity during this time period. Thus, the problem is larger than this one set of culverts. To reduce hypersalinity at PL, restoration would likely need to more directly reconnect that area to the GIWW.

Fig. 28. The low-lying Chinquapin Road separates the Lake Austin watershed from the Big Boggy Creek watershed (left), and has only two small culverts running under it (right).

Chinquapin Road also floods with very high tides and this creates evacuation issues for the residents of the small fishing community along Live Oak Bayou. Thus, there is likely still some benefit to be gained by installing a small bridge or larger culverts at this location.

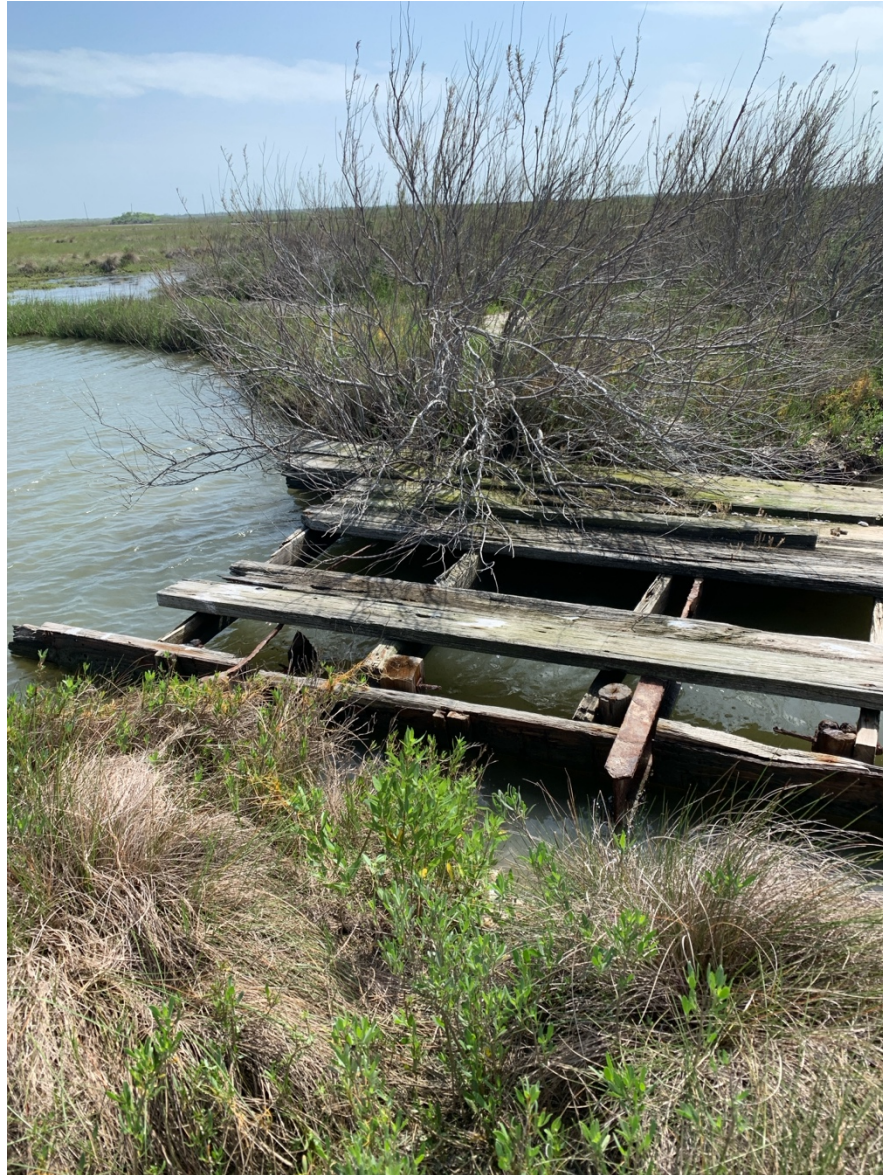
There is an old, damaged bridge that could be removed along Chinquapin Bayou (Fig. 29). This structure lies within the Big Boggy NWR. The structure is not blocking hydrologic flow, but it is no longer in use and is in disrepair. It should be removed.

Fig. 29. An old, damaged bridge on Chinquapin Bayou.

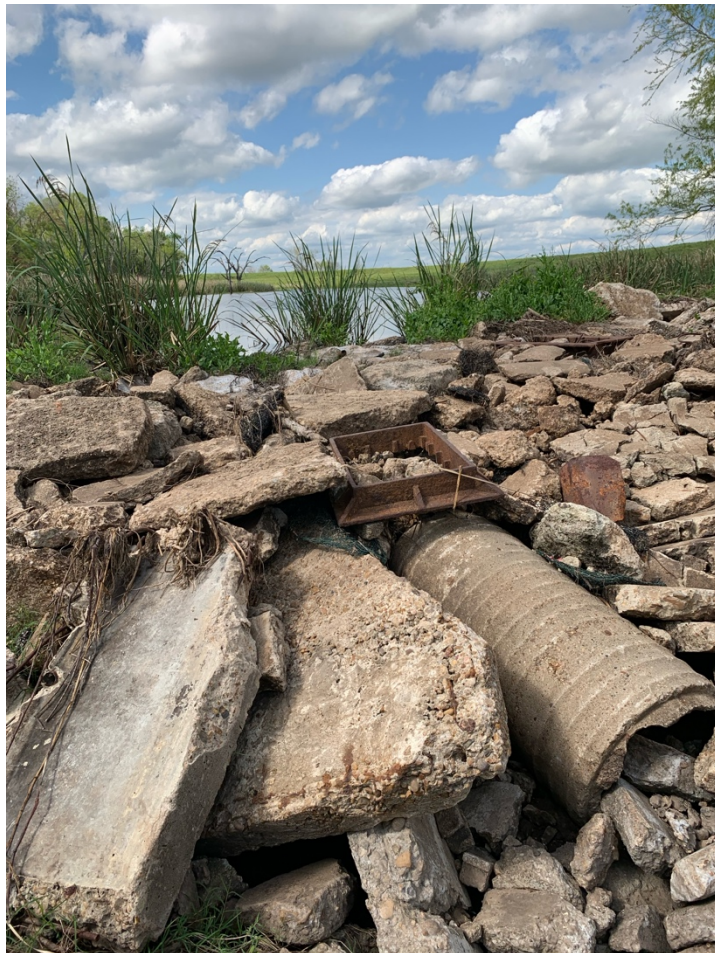
There is an old, damaged dam that needs to be repaired and/or removed along Live Oak Bayou (Fig. 30). The intention of this dam is to block saline water from traveling upstream, while also allowing freshwater to travel downstream. The dam currently allows some water to travel under its rocks, so it does not appear to be in optimal shape for its intended purpose. Some salt water is able to go upstream during storm surges, yet the dam blocks most fish passage in both directions. Just upstream from the dam, the habitat is good for alligators and water hyacinth due to pooling. From an ecological perspective, it would be better to remove the dam for hydrologic connectivity and fish passage.

Fig. 30. An old, damaged dam that obstructs some hydrologic connection on the upper portion of Live Oak Bayou.

However, the dam currently keeps the upstream water fresher, which helps stakeholders and landowners as those who own crawfish farms, rice farms, and other agricultural interests. Because it is in disrepair and allows some salt water to pass under the rocks, an ideal solution would repair the dam to prevent further intrusion, but in a manner that would also allow for greater fish passage.
