**Rollover Pass
Erosion and Hazard-related Issues**

December 8, 2011

Executive Summary

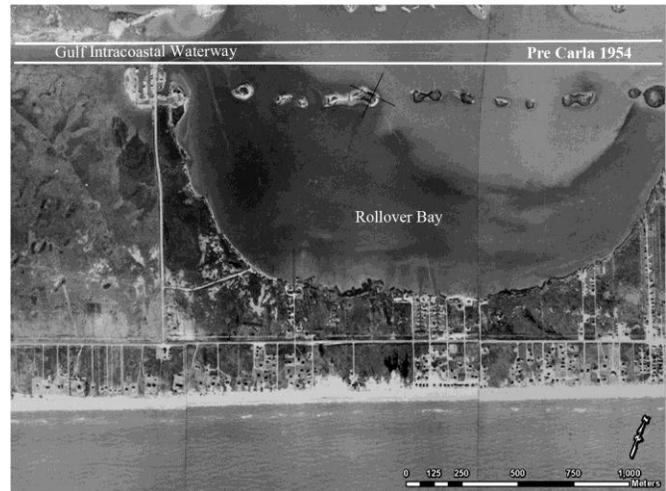
Figure 1 Rollover Pass Area Pre-Construction 1954

The Pass is located in the narrowest part of Bolivar Peninsula (Figure 1) within a natural washover area, which is periodically breached by sheet flow during tropical storms and hurricanes. Prior to the construction of the Pass, the natural process in the area during high tide and storm events allowed sediment to be transported offshore and deposited in offshore sand bars. The sand reservoir provided sediment for rebuilding the beach and dunes after a storm event and provided sediment to shorelines to the southwest along the littoral drift.

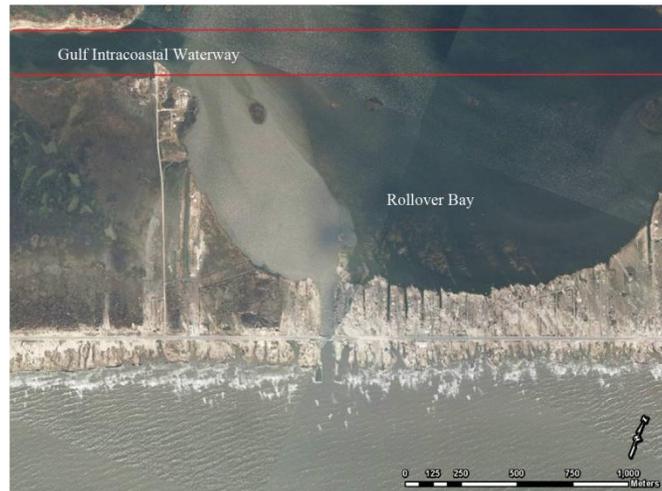
Figure 2. Rollover Pass Post-Ike 2008

The Pass also increases the vulnerability of Bolivar Peninsula to being breached by storm surge and wave action. With the Pass causing accelerated erosion rates and a reduction in the sand volume required to maintain the natural beach conditions along the adjacent Gulf shoreline, there is a concern that a large high energy storm or subsequent storms could result in the washover area of the Pass being opened to the Gulf of Mexico. An additional concern is the poor conditions of the steel bulkheads lining the Pass. The bulkheads are susceptible to failure even in high tide and smaller storm events. Failure of the bulkheads will result in rapid expansion of the channel from tidal scour as was seen in 1955 when the Pass was constructed. If the portion of the GIWW near Rollover Pass becomes open to the Gulf of Mexico, the GIWW will no longer be navigable. Bolivar came dangerously close to being breached by Hurricane Ike within the Rollover Pass area as shown in Figure 2.

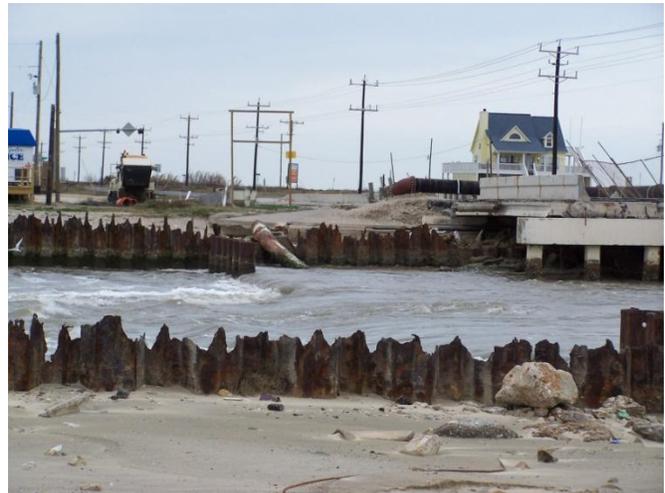
Figure 3. Rollover Pass north of Highway 87

Numerous health and safety concerns pose significant issues for the public frequenting Rollover Pass. The bulkheads of the Pass are constructed of steel sheet piles with a concrete cap that serves as a walking surface for the public. The bulkheads sustained significant, and currently unrepaired, damage as a result of Hurricane Ike. Concrete slabs provided a wide sidewalk adjacent to the bulkheads. In many places, these concrete slabs are dislodged or have subsided. The current sidewalks are significantly damaged with many tripping and falling hazards.

Due to wave attack associated with Hurricane Ike, the handrail system on top of the bulkheads sustained significant damage. In many places it provides no protection to prevent pedestrians from falling 10 feet into the waters below. The areas north of Highway 87 were not constructed with a concrete cap, and corrosion to the steel sheet piles has left a jagged top with potential safety hazards (Figure 3). Additionally, Rollover Pass does not meet Americans with Disabilities Act (ADA) guidelines or Texas Accessibility Standards (TAS). Rollover Pass has experienced significant erosion near the sheet piles lining the Pass. Weaknesses to the sheet piles, caused by corrosion, also

increase the likelihood of structural failure and collapse of the sidewalls. This damage, coupled with the fact that Rollover Pass is not ADA or TAS compliant, could lead to localized failures and major safety issues, putting the general public in danger.
